# Inspection Report

**Property Address:**  
123 Main Street  
Middleton Wi

### Badger Property Inspection

<b>Date:</b> 12/24/2024	<b>Time:</b> 08:00 AM	<b>Report ID:</b> 2955
<b>Property:</b> 123 Main Street Middleton Wi	<b>Customer:</b> Sample Report	<b>Real Estate Professional:</b>

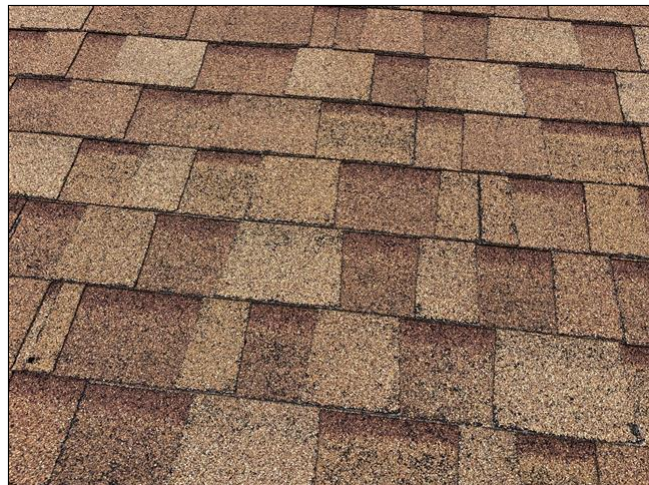
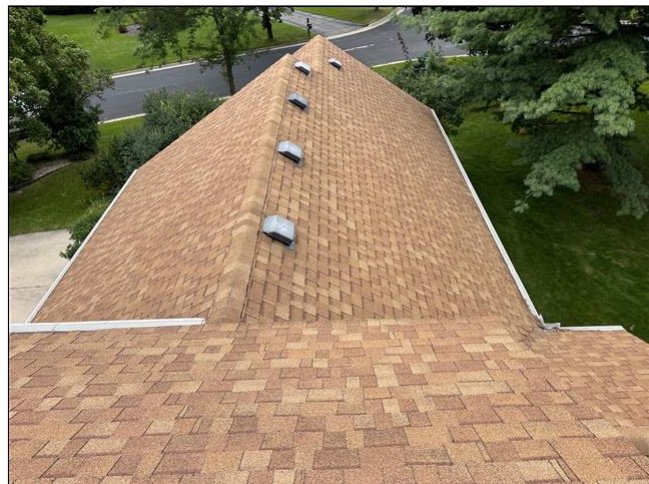
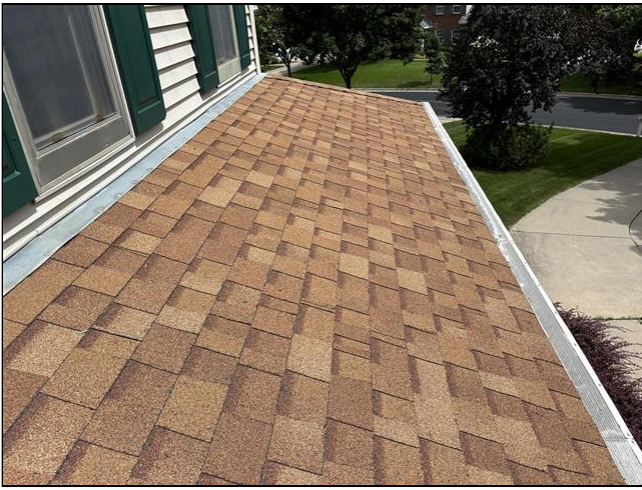
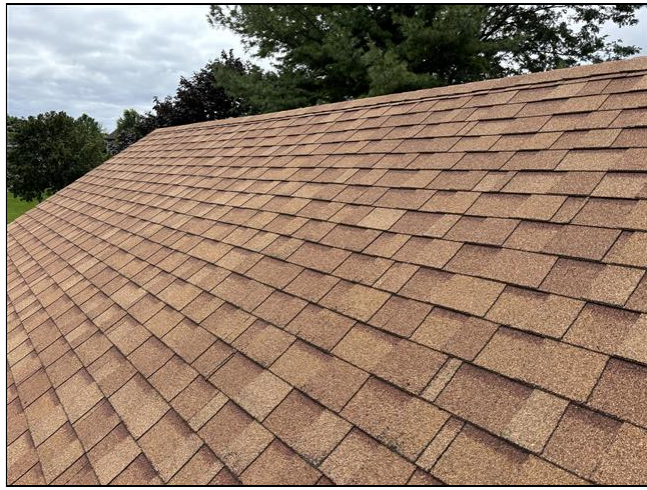
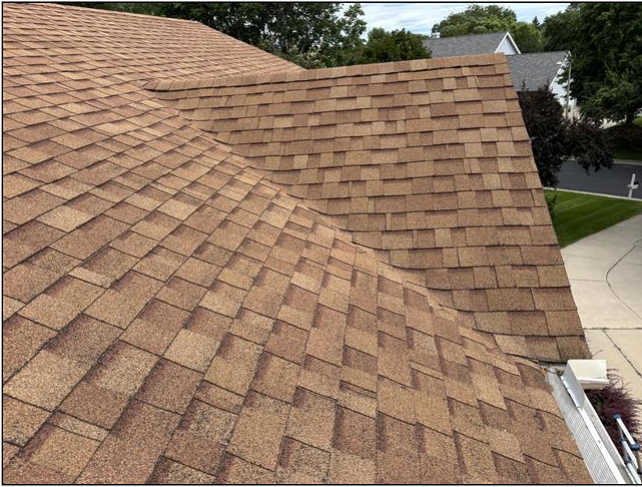
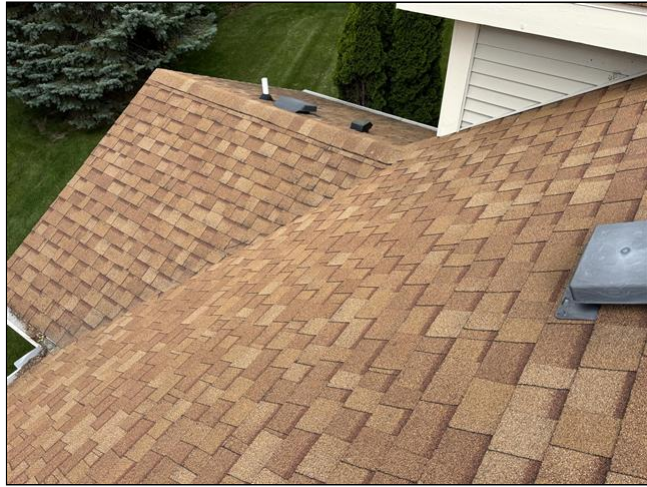
**1.0** Architectural asphalt shingles have a life expectancy of 30 years and the estimated homes roof is 15 to 20 years old. I did not see any missing shingles, cracks, hail damage, curling to shingles, See Pictures. Shingles are showing their age as some granular loss is visible but are in serviceable condition. Recommend budgeting for new roof as needed. Regular inspections and maintenance recommended to ensure roofing material will remain in serviceable condition.

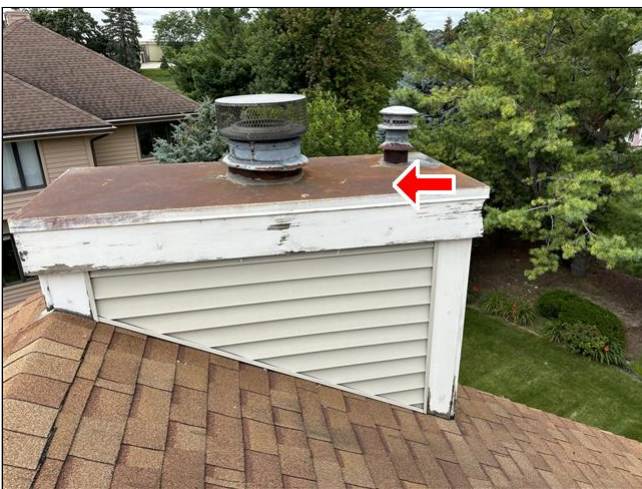
**1.2** Metal chimney cap is rusting and in need of replacement or possibly sanding and applying a protective coating to reduce further rusting of metal chimney cap. Further rusting can cause leaking into chimney chase. Qualified chimney technician to evaluate and provide options to correct rusting issue of the chimney cap.

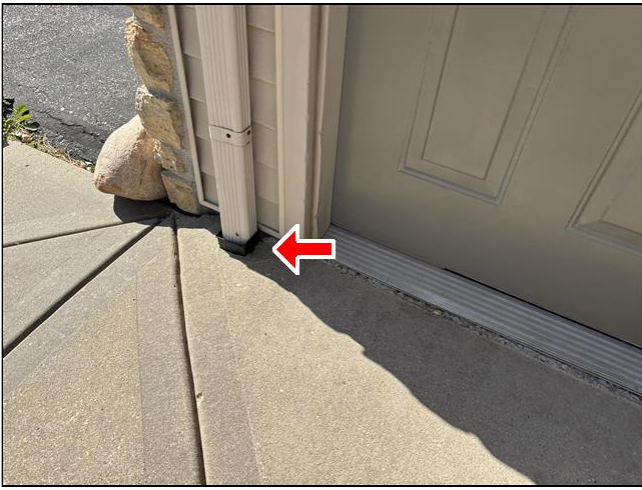
**1.3** Recommend asking seller about exterior downspouts along side of home and where they exit into the yard below, Having this information will help you monitor and ensure they are draining properly.

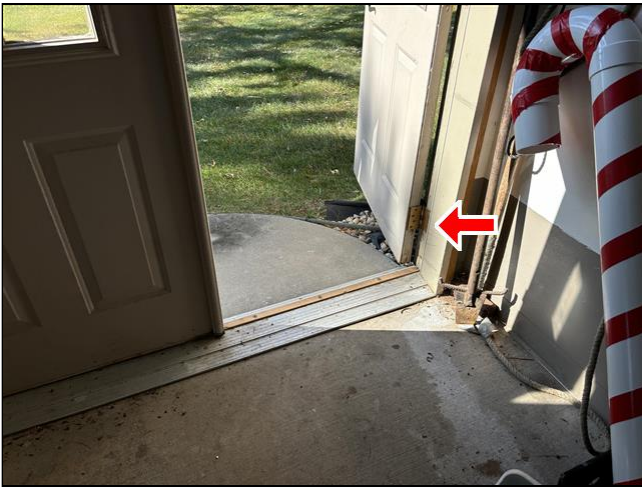
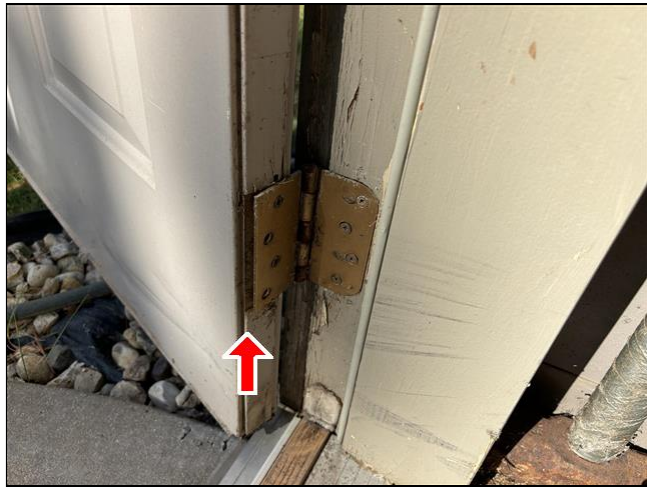
**2.1** Lower door hinge to side entrance of storage room is coming loose as visible moisture damage to door frame found, this is causing door to bind against frame when trying to open/close. Recommend qualified person or contractor ensure door hinge can be properly tightened so hinge is secure and not loose, the door will need to be properly supported by hinges to open/close properly.

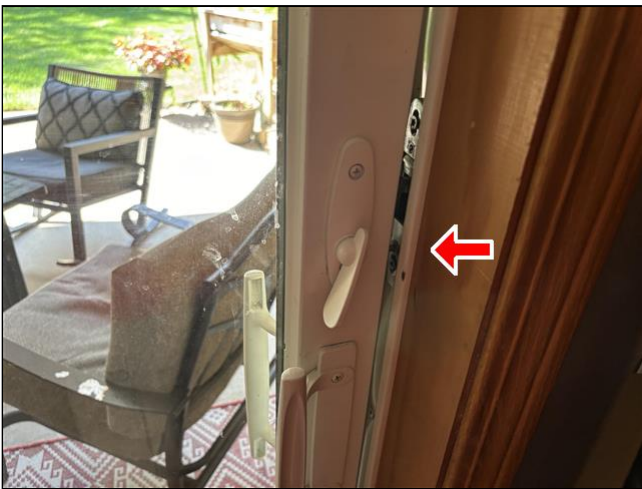
**2.1** Master bedroom sliding glass door to rear deck did not lock properly as latch is mis-adjusted, Recommend a qualified person or technician properly adjust door latch to ensure door can be locked properly for safety of occupants in the home.

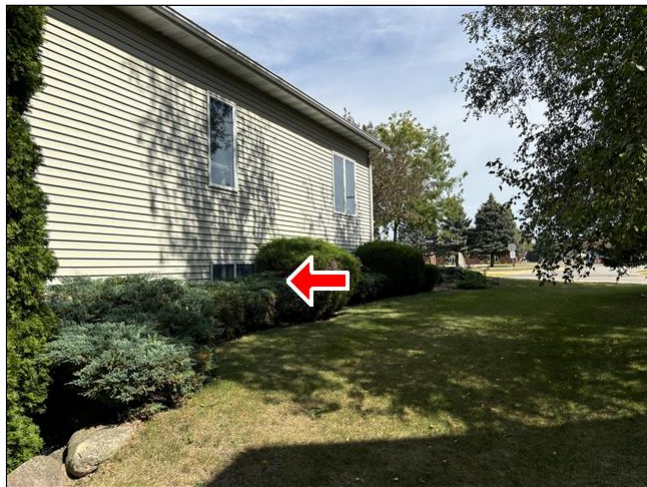
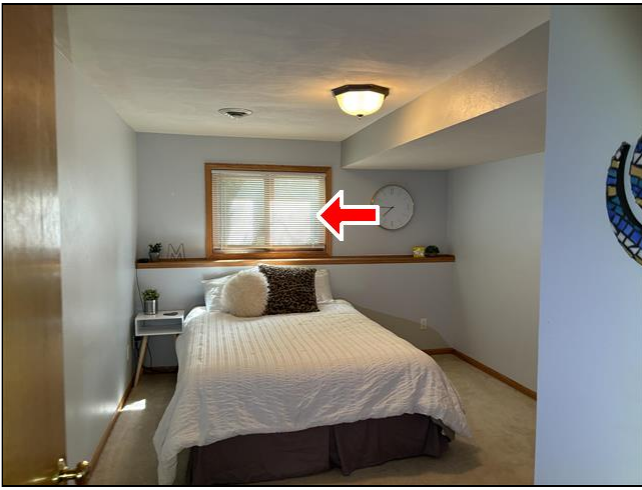
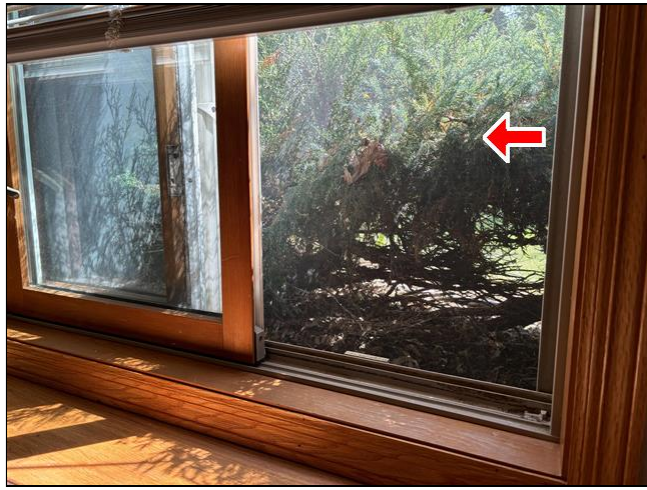
**2.2** Lower bedroom egress window blocked by over growth of bushes(see pictures), this is a safety issue and should be corrected by removing exterior bushes in front of the window in case there ever is a cause to escape the room including due to a fire, the escape route should never be blocked.

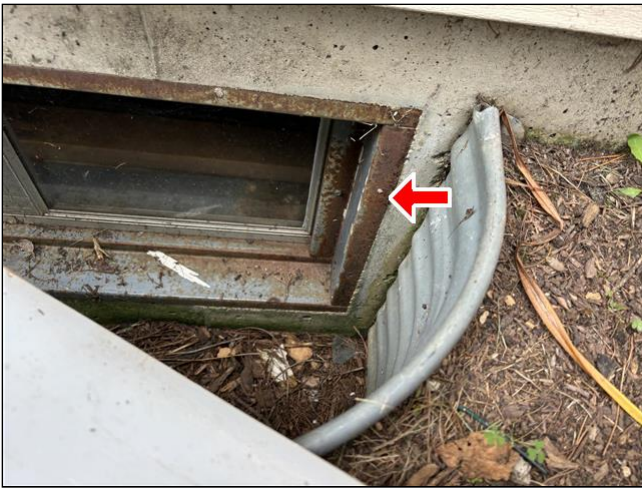
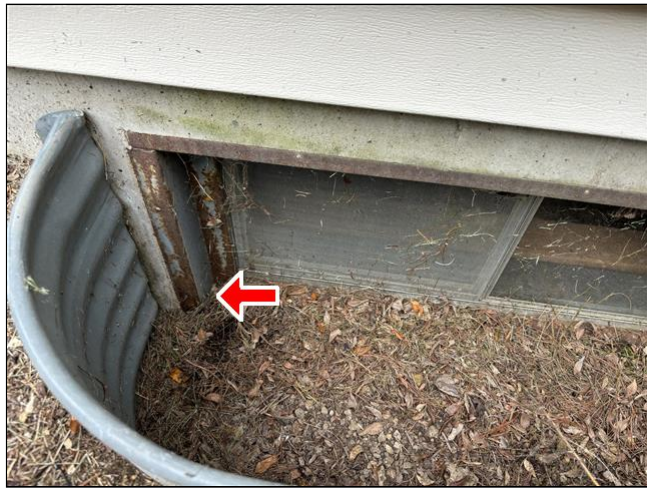
**2.2** Window well metal frames are starting to rust. Recommend removing surface rust and applying a protective paint to protect metal from the elements and further rusting. Regular maintenance is recommended as much less expensive to add a coat of paint when needed than replace metal window frame once frame has deteriorated/rusted through.

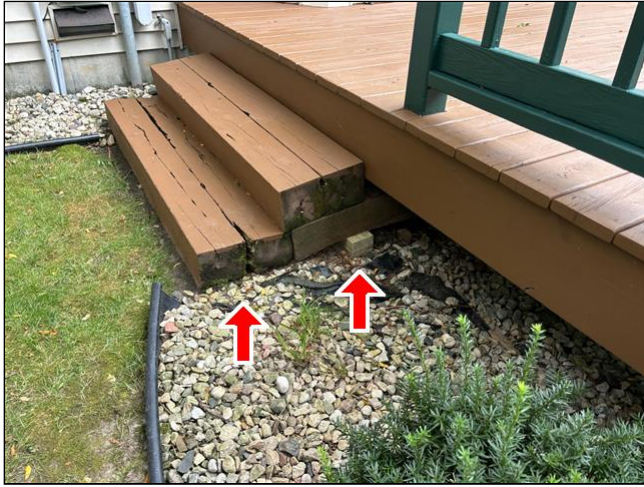
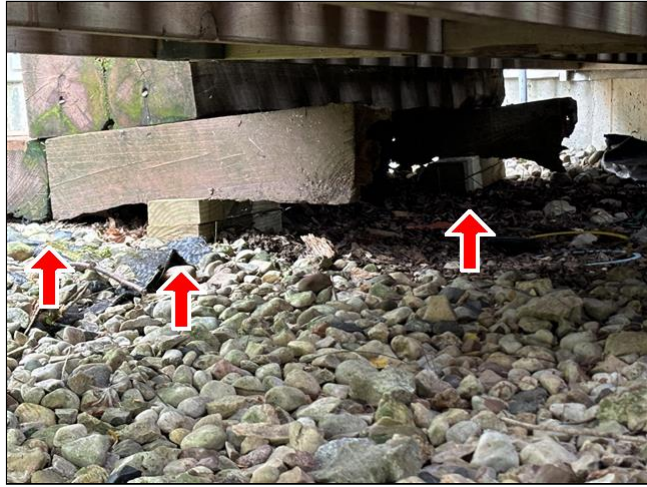
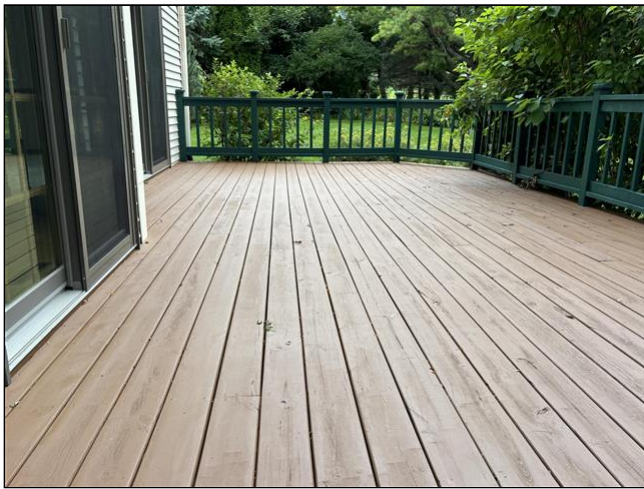
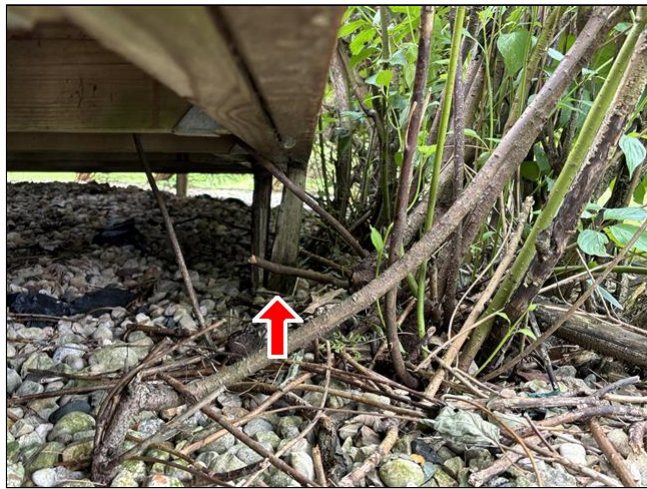
**2.3** The Wood deck posts supporting the main deck are older and several posts are failing. The wood posts are rotted and/or split and could cause the deck to collapse at some point. Recommend a qualified contractor evaluate and determine repairs needed to ensure the deck is safe for use. Also the deck steps have moved due to visible moisture damage and wood rot found. Temporary repairs made to the deck steps were visible. Deck stairs will need repairs and/or possible full replacement.

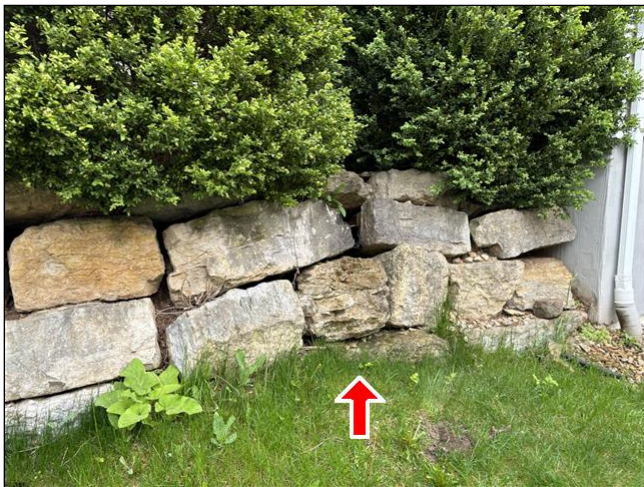
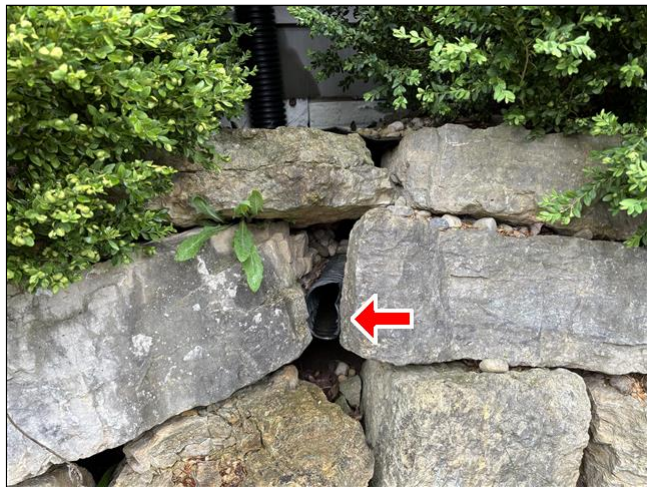
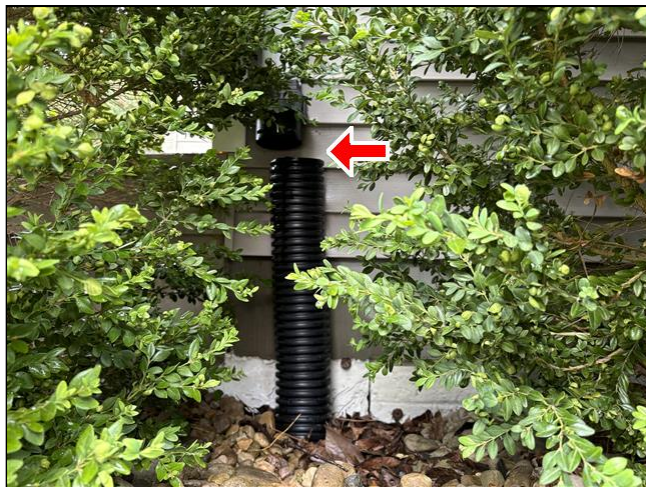
**2.4** Downspout along right side of home has come disconnected allowing water to drain down behind retaining wall causing settling of the stones as seen in the pictures. Recommend ensuring the downspout is re-connected and water is directed out past the retaining wall as intended. Unknown if further settling of the retaining wall will occur over time. Recommend monitoring area and making repairs to the wall as needed.

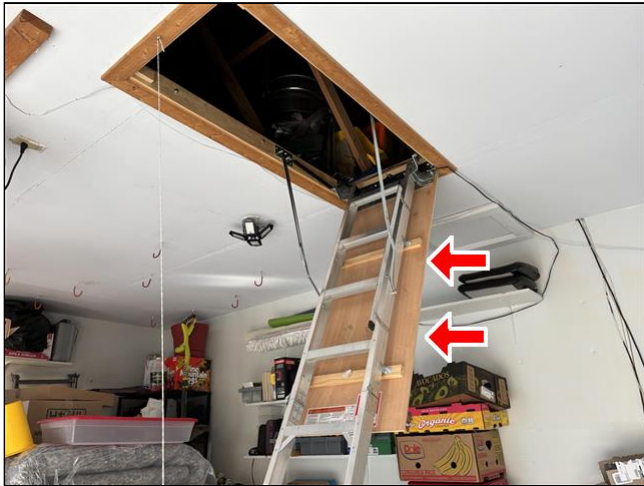
**3.0** Fire barrier between garage and attic space was broken due to attic ladder being installed and not being a fire rated ladder. The ladder assembly panel is only a 1/4 inch piece of wood or less in thickness so if fire was to occur in garage it would be able to enter into the attic area rather quickly. Recommend installing protective fire barrier material over the ladder panel so the fire barrier will be maintained or consider upgrading to a fire rated ladder assembly.

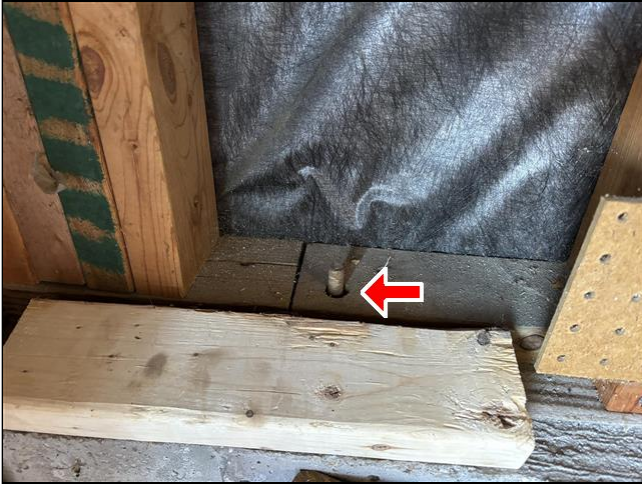
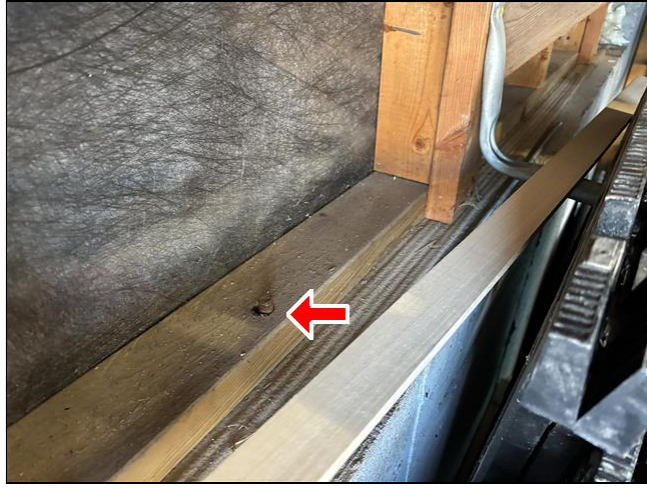
**3.1** The anchor screws along garage foundation are missing the required washers and nuts used to secure the garage structure to the concrete foundation as seen in pictures. Recommend qualified person or contractor properly secure garage structure to foundation.

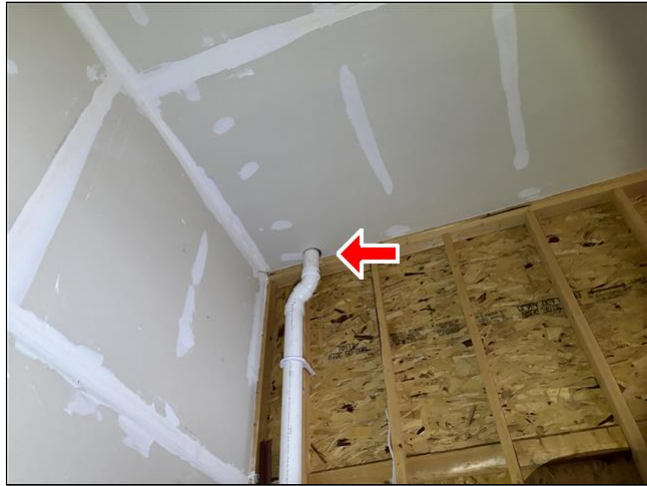
**3.1** When the radon mitigation system was installed in the home, an exhaust pipe was routed from basement up in to garage area and then up through the garage ceiling as seen in the pictures. It is recommended to install fire rated collars around the pipes along the wall where the pipe enters the garage and along the ceiling where the exhaust pipe exits up into the attic space. The fire collars are installed to ensure the fire barrier is maintained between the garage and living spaces of the home as the collars will expand and seal off the openings in the wall and ceiling if a fire does occur in the garage. Recommend a qualified person or contractor install the missing fire barrier collars in garage.

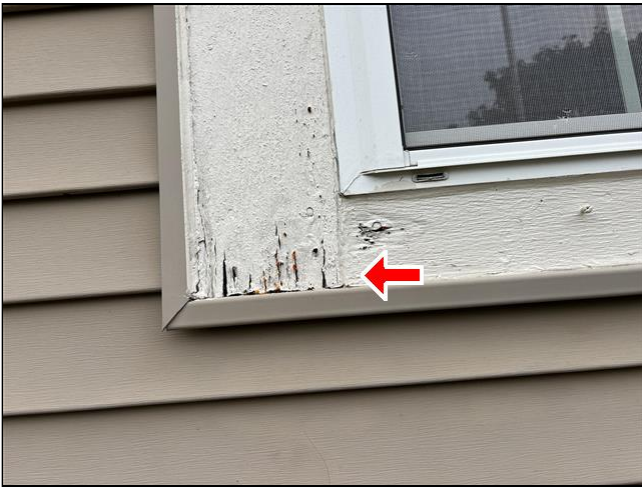
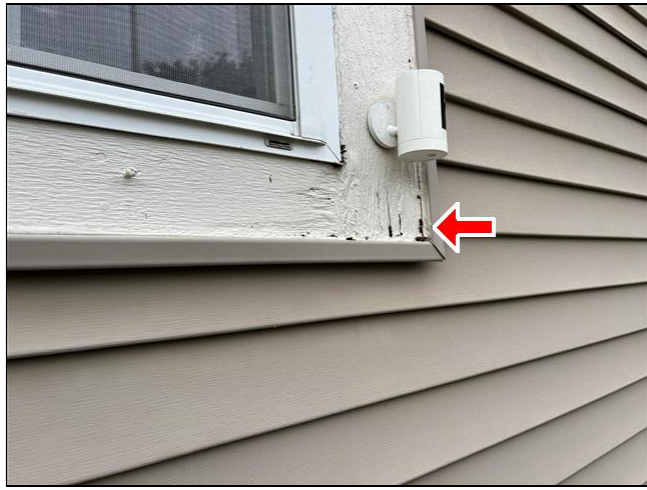
**3.6** Wood window trim along side of the garage has visible moisture damage as seen in the pictures. Recommend qualified person replace the damaged wood trim as needed and ensure the wood is primed and painted to protect the trim around the windows from further deterioration over time. This is considered regular maintenance.

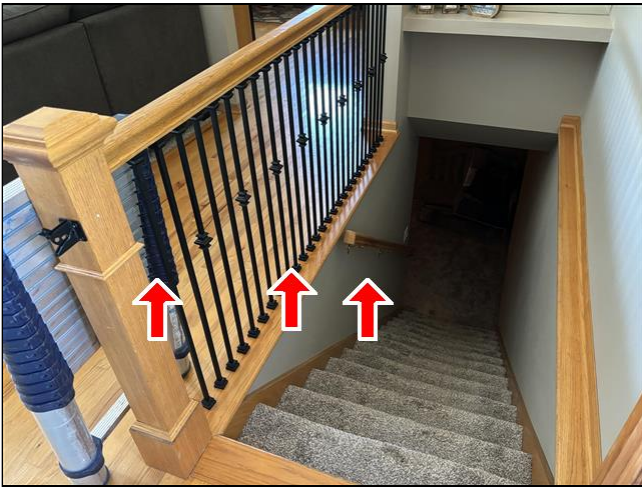
**4.3** No graspable hand rail along the entire length of the stairs was found leading to the basement area of the home. Recommend installing a hand rail along entire length of the steps to meet today's safety standards. A fall or injury could occur if not corrected. A qualified contractor or person is recommended to perform the work.

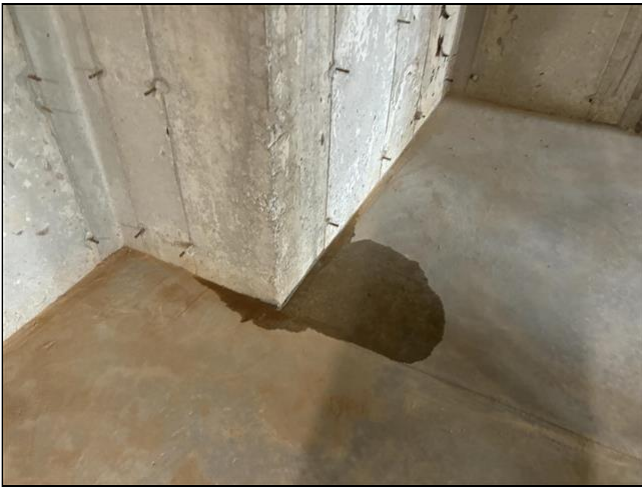
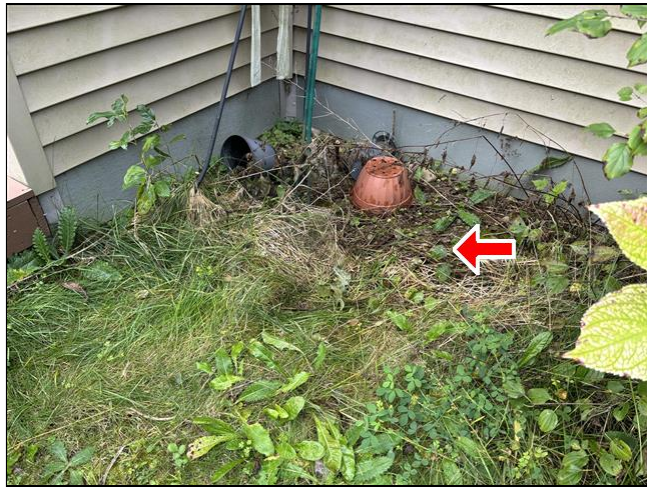
**5.0** It is not uncommon for a home of this age to have signs of water/moisture stains in the basement. Seepage in basement along back wall wall found at time of the inspection, Poor grading at rear of the home found as the ground slopes towards the foundation allowing water to drain down along the concrete foundation. It is impossible to predict the severity or frequency of water leak issues on a one time visit. Recommend a qualified landscape company improve the grading at rear of the home so water will drain away from the home. Further monitoring well be needed to determine if further improvements will be needed. Most water issues in basements are due to poor water management around the home which includes grading/ sloping of ground around home and maintaining gutters/downspouts so they are in proper working order. Concrete foundations are not water proof and if water is allowed to run down along the concrete foundation, water will most likely seep into the basement.

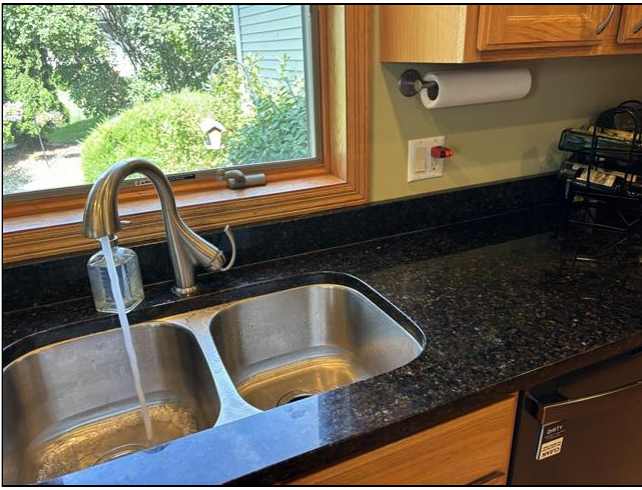
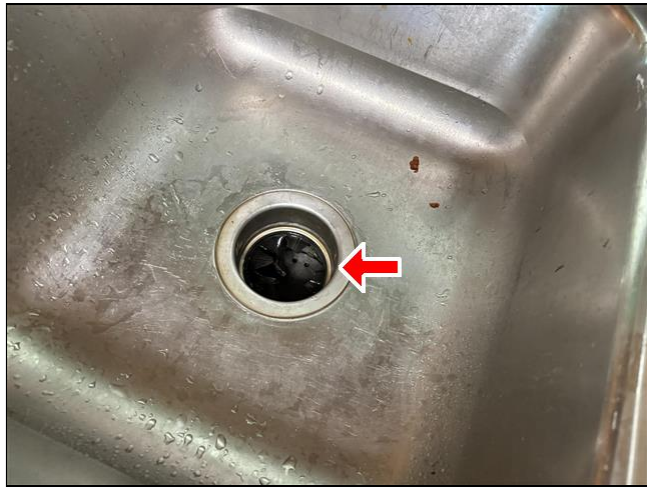
**6.0** Garbage disposal gasket is missing/deteriorated as seen in picture, recommend qualified person or plumber replace the missing/deteriorated disposal gasket as this will help reduce splash back along with reducing the chance of a future leak under the sink.

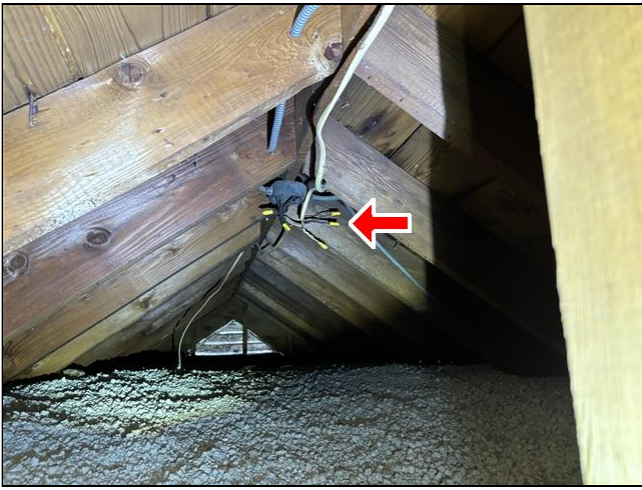
**7.3** Open wiring connections (splices) found in attic space above the garage which should be placed in an enclosed electrical junction box, Recommend a qualified electrician repair wiring issues in attic space above garage. This is considered an electrical safety issue until corrected.

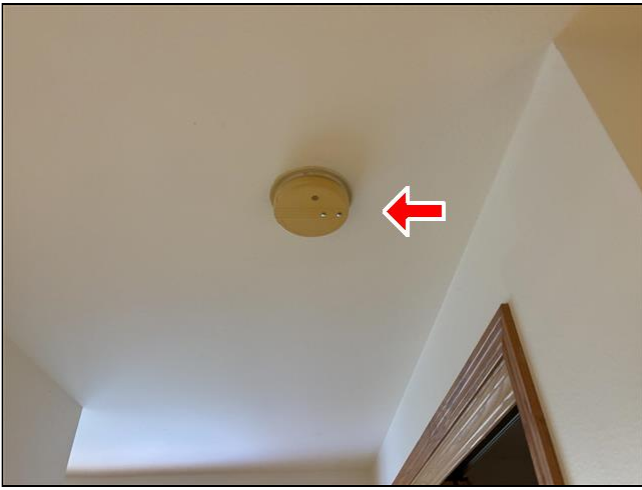
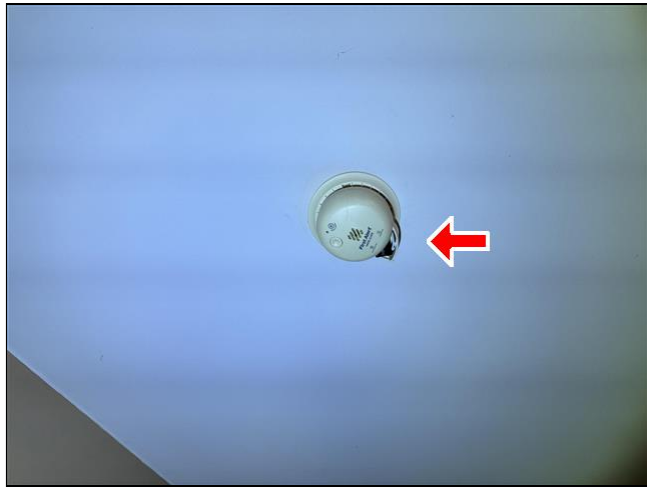
**7.7** Several of the smoke detectors on 2nd floor and on main floor are well beyond the manufacturers recommended 10 year replacement date. Recommend replacing smoke detectors and installing per manufacturers instructions. All smoke detectors should be tested upon move in and placed on a monthly testing program to ensure they are working properly. State of Wisconsin requires a minimum of one smoke detector per floor of home, but recommend referencing you to your particular local code. Some municipalities want smoke detectors installed in the following areas: In each bedroom, within 6 feet of each door leading to a bedroom or sleeping area and at least one smoke detector on each floor of a building. Also the smoke detector in the basement is missing and new detector should be installed.

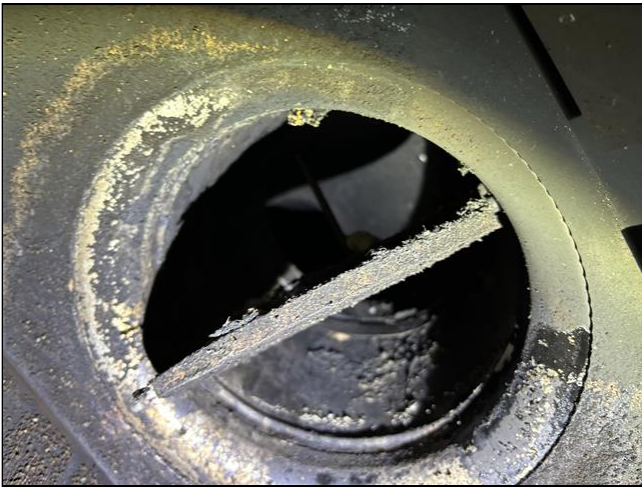
**8.6** The home inspection is a component inspection and not a functionality inspection. I do not inspect the shape of fireplace or the design to determine if your fireplace has a proper air draw(drafting). Recommend a certified chimney inspector inspect the chimney flue prior to use as they can determine the condition of the flue and whether safe to use. It is never recommended to leave the fireplace un-attended when in use. Also should be noted that the chimney liner was not visible due to dampener and chimney rain cap, recommend a licensed chimney company clean and inspection flue as creosote dust may conceal a hairline crack until properly cleaned and inspected. I recommend a qualified chimney sweep inspect for safety prior to first use as unknown when fireplace was last used or inspected.

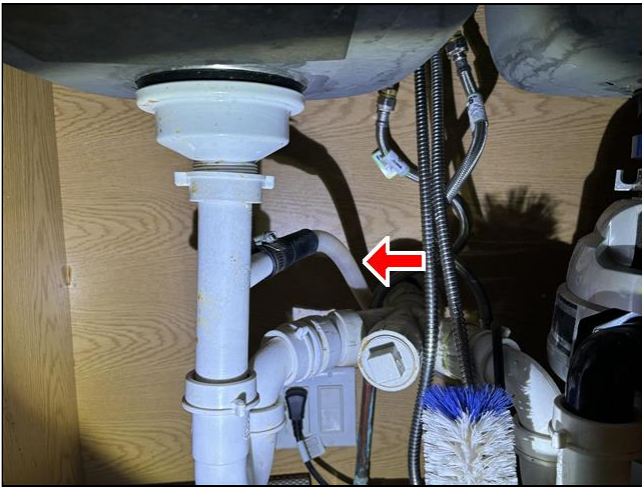
**10.0** No above counter top air gap or a high loop below in vanity for dishwasher discharge was found. It is recommend to have an air gap device which can prevent contaminated water from draining back into the dishwasher. Recommend a qualified plumber install proper air gap device.

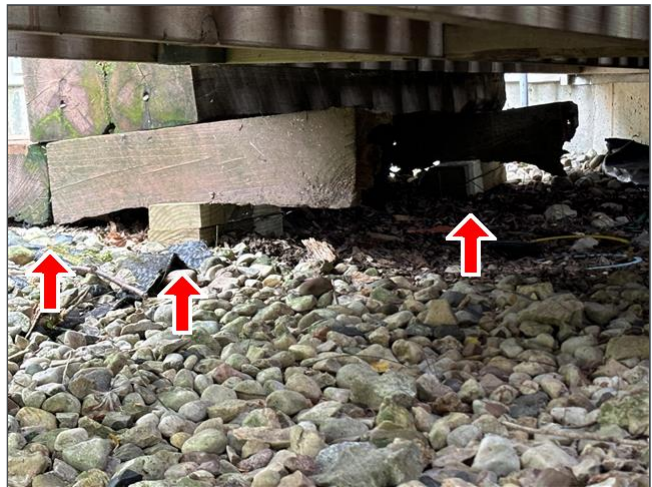
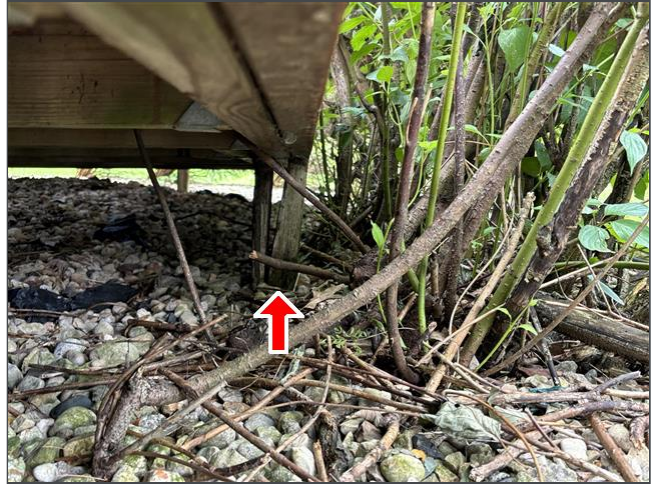
#### 2.3 Decks, Balconies, Stoops, Steps, Areaways, Porches, Patio/Cover and Applicable Railings

The Wood deck posts supporting the main deck are older and several posts are failing. The wood posts are rotted and/or split and could cause the deck to collapse at some point. Recommend a qualified contractor evaluate and determine repairs needed to ensure the deck is safe for use. Also the deck steps have moved due to visible moisture damage and wood rot found. Temporary repairs made to the deck steps were visible. Deck stairs will need repairs and/or possible full replacement.

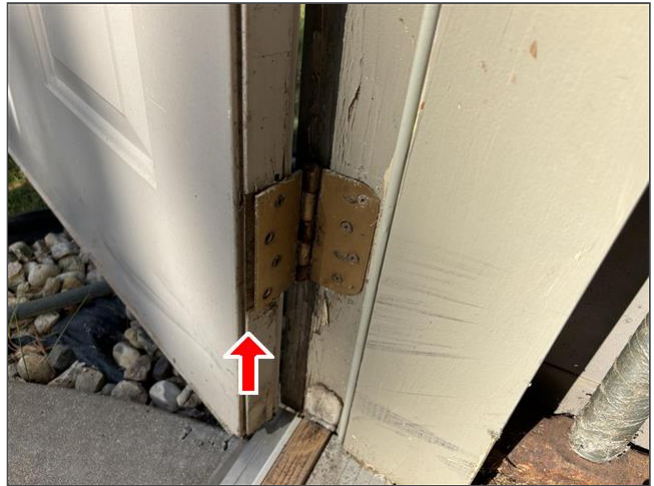
**2.1 Doors (Exterior)**

Lower door hinge to side entrance of storage room is coming loose as visible moisture damage to door frame found, this is causing door to bind against frame when trying to open/close. Recommend qualified person or contractor ensure door hinge can be properly tightened so hinge is secure and not loose, the door will need to be properly supported by hinges to open/close properly.

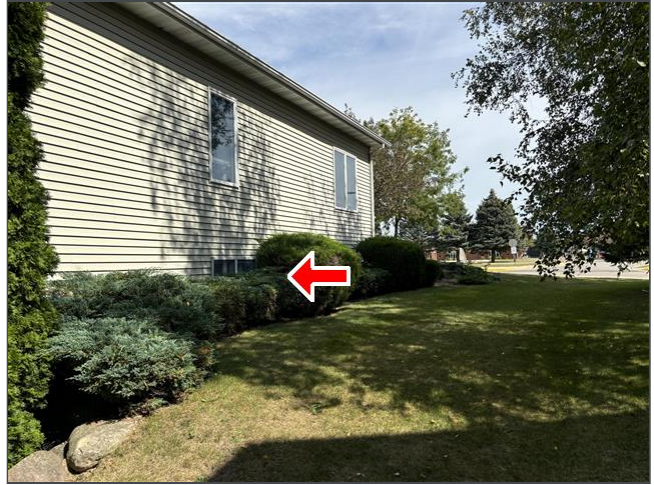
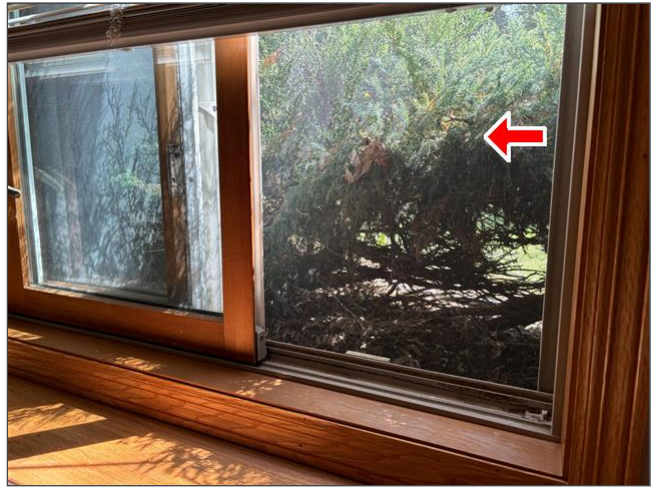
**2.2 Windows**

Lower bedroom egress window blocked by over growth of bushes(see pictures), this is a safety issue and should be corrected by removing exterior bushes in front of the window in case there ever is a cause to escape the room including due to a fire, the escape route should never be blocked.

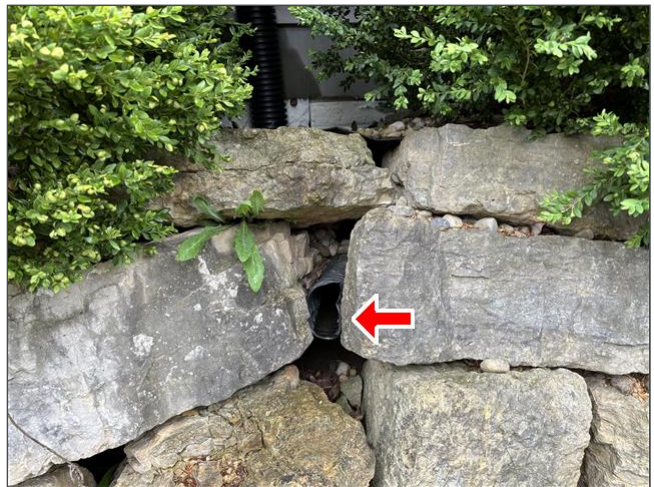
**2.4 Vegetation, Grading, Drainage, Driveways, Patio Floor, Walkways and Retaining Walls (With respect to their effect on the condition of the building)**

Downspout along right side of home has come disconnected allowing water to drain down behind retaining wall causing settling of the stones as seen in the pictures. Recommend ensuring the downspout is re-connected and water is directed out past the retaining wall as intended. Unknown if further settling of the retaining wall will occur over time. Recommend monitoring area and making repairs to the wall as needed.

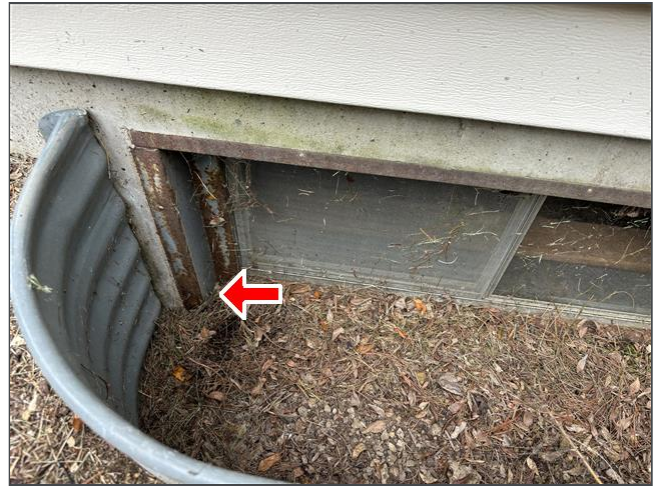
### **2.2 Windows**

Window well metal frames are starting to rust. Recommend removing surface rust and applying a protective paint to protect metal from the elements and further rusting. Regular maintenance is recommended as much less expensive to add a coat of paint when needed than replace metal window frame once frame has deteriorated/rusted through.

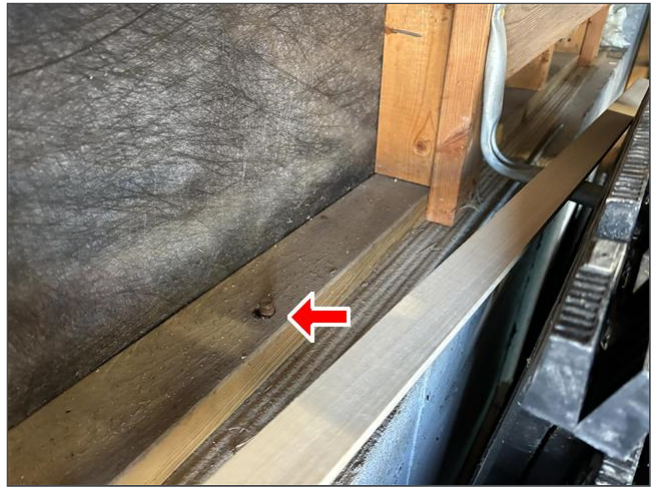
**3.1 Garage Walls (including Firewall Separation)**

The anchor screws along garage foundation are missing the required washers and nuts used to secure the garage structure to the concrete foundation as seen in pictures. Recommend qualified person or contractor properly secure garage structure to foundation.

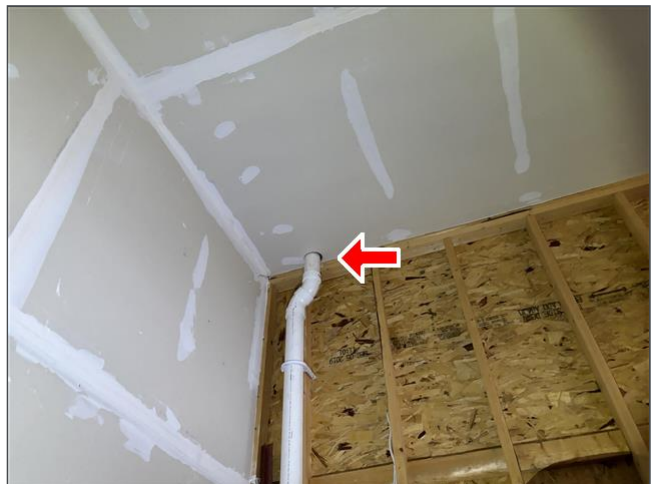
When the radon mitigation system was installed in the home, an exhaust pipe was routed from basement up in to garage area and then up through the garage ceiling as seen in the pictures. It is recommended to install fire rated collars around the pipes along the wall where the pipe enters the garage and along the ceiling where the exhaust pipe exits up into the attic space. The fire collars are installed to ensure the fire barrier is maintained between the garage and living spaces of the home as the collars will expand and seal off the openings in the wall and ceiling if a fire does occur in the garage. Recommend a qualified person or contractor install the missing fire barrier collars in garage.

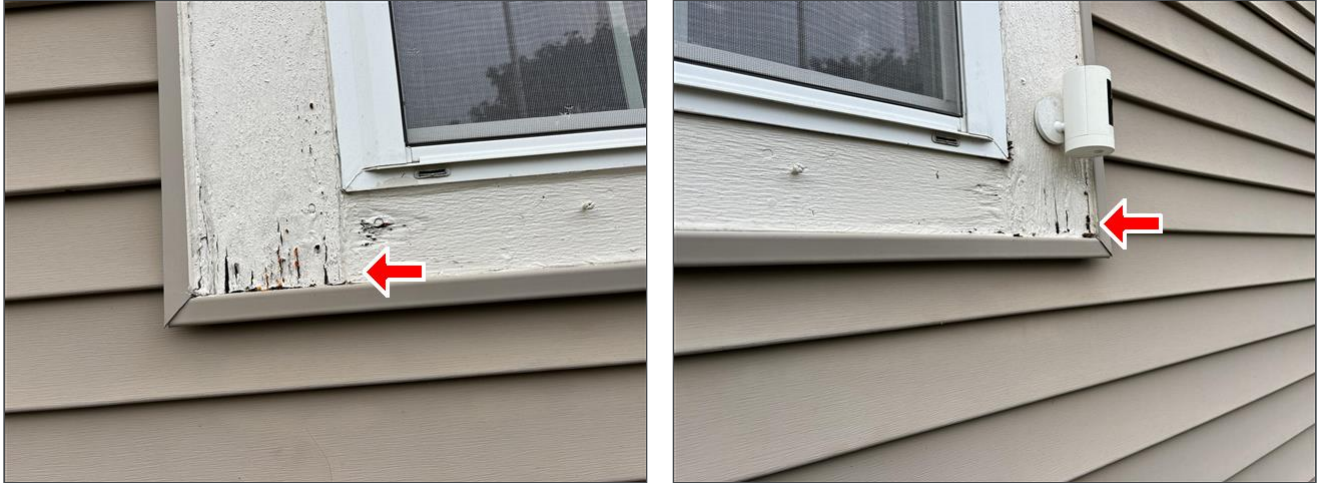
### 3.6 Windows

Wood window trim along side of the garage has visible moisture damage as seen in the pictures. Recommend qualified person replace the damaged wood trim as needed and ensure the wood is primed and painted to protect the trim around the windows from further deterioration over time. This is considered regular maintenance.

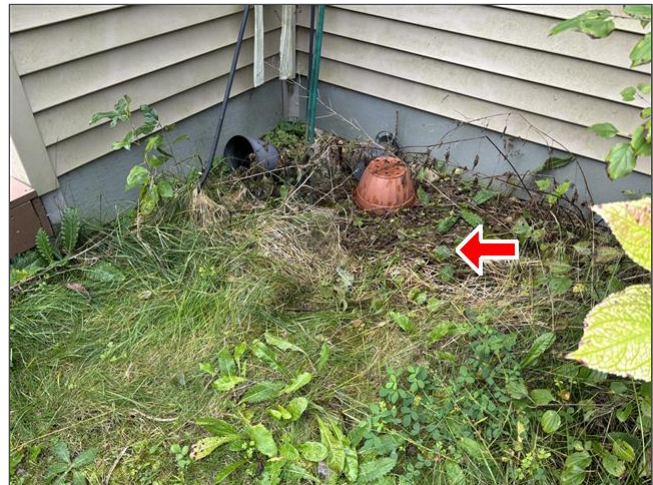
It is not uncommon for a home of this age to have signs of water/moisture stains in the basement. Seepage in basement along back wall wall found at time of the inspection, Poor grading at rear of the home found as the ground slopes towards the foundation allowing water to drain down along the concrete foundation. It is impossible to predict the severity or frequency of water leak issues on a one time visit. Recommend a qualified landscape company improve the grading at rear of the home so water will drain away from the home. Further monitoring well be needed to determine if further improvements will be needed. Most water issues in basements are due to poor water management around the home which includes grading/sloping of ground around home and maintaining gutters/downspouts so they are in

proper working order. Concrete foundations are not water proof and if water is allowed to run down along the concrete foundation, water will most likely seep into the basement.

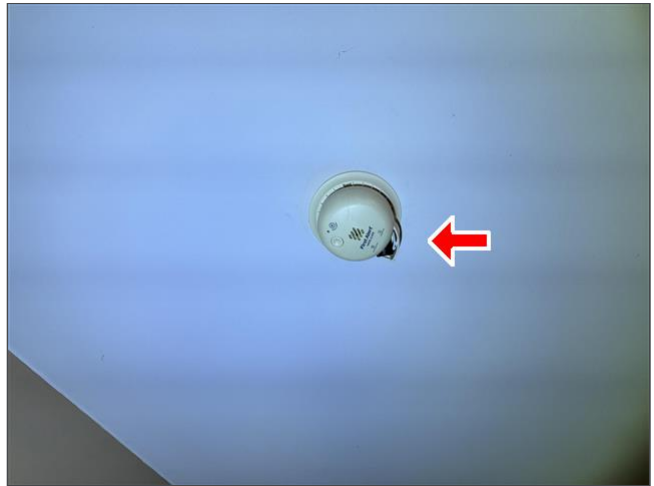
### 7.7 Smoke Detectors

Several of the smoke detectors on 2nd floor and on main floor are well beyond the manufacturers recommended 10 year replacement date. Recommend replacing smoke detectors and installing per manufacturers instructions. All smoke detectors should be tested upon move in and placed on a monthly testing program to ensure they are working properly. State of Wisconsin requires a minimum of one smoke detector per floor of home, but recommend referencing you to your particular local code. Some municipalities want smoke detectors installed in the following areas: In each bedroom, within 6 feet of each door leading to a bedroom or sleeping area and at least one smoke detector on each floor of a building. Also the smoke detector in the basement is missing and new detector should be installed.

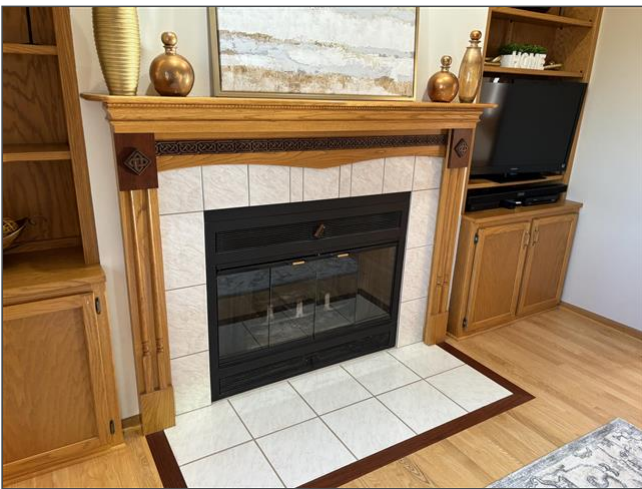
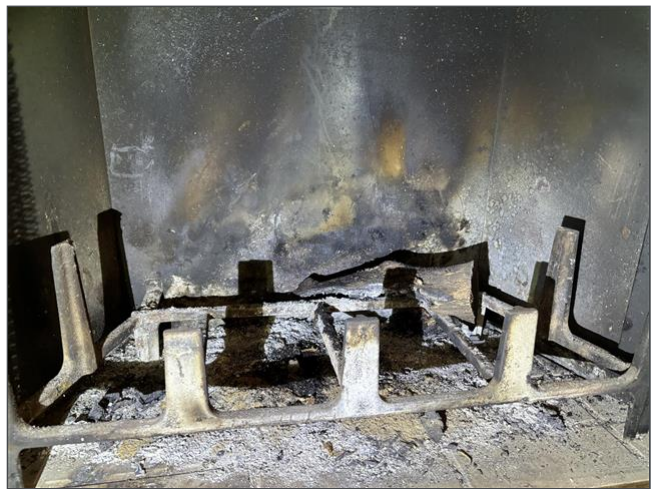
**8.6 Solid Fuel Heating Devices (Fireplaces, Woodstove)**

The home inspection is a component inspection and not a functionality inspection. I do not inspect the shape of fireplace or the design to determine if your fireplace has a proper air draw(drafting). Recommend a certified chimney inspector inspect the chimney flue prior to use as they can determine the condition of the flue and whether safe to use. It is never recommended to leave the fireplace un-attended when in use. Also should be noted that the chimney liner was not visible due to dampener and chimney rain cap, recommend a licensed chimney company clean and inspection flue as creosote dust may conceal a hairline crack until properly cleaned and inspected. I recommend a qualified chimney sweep inspect for safety prior to first use as unknown when fireplace was last used or inspected.

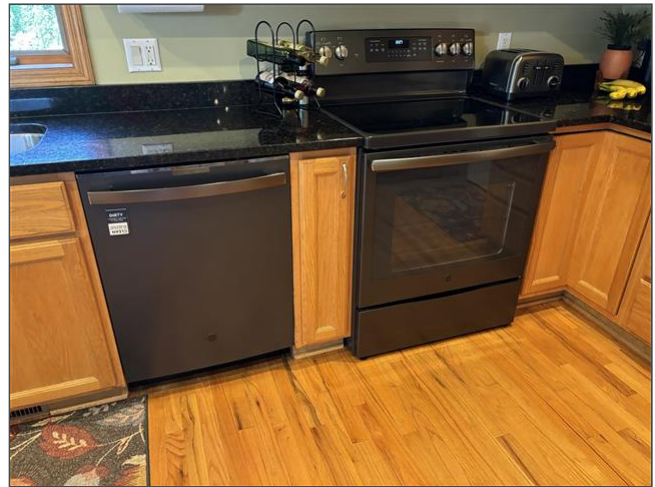
#### 10.0 Dishwasher

No above counter top air gap or a high loop below in vanity for dishwasher discharge was found. It is recommend to have an air gap device which can prevent contaminated water from draining back into the dishwasher. Recommend a qualified plumber install proper air gap device.
