# Inspection Report

**Property Address:**  
123 Main Street  
Middleton Wi

### Badger Property Inspection

<b>Date:</b> 12/24/2024	<b>Time:</b> 08:00 AM	<b>Report ID:</b> 2955
<b>Property:</b> 123 Main Street Middleton Wi	<b>Customer:</b> Sample Report	<b>Real Estate Professional:</b>

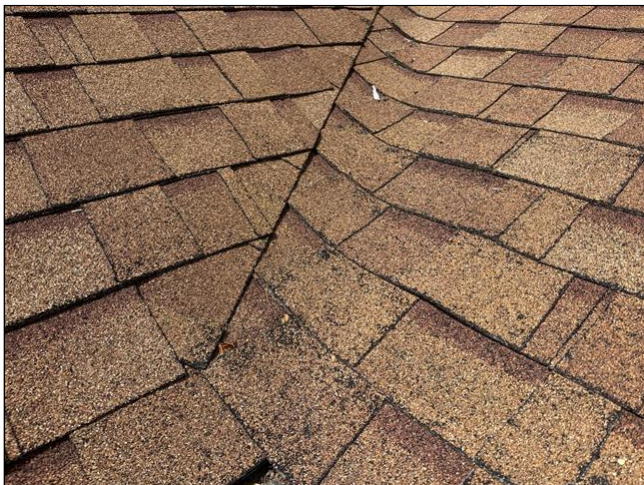
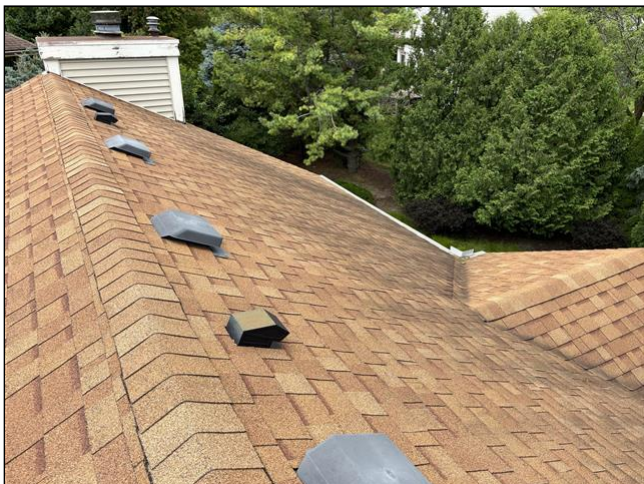
**1.0** Architectural asphalt shingles have a life expectancy of 30 years and the estimated homes roof is 15 to 20 years old. I did not see any missing shingles, cracks, hail damage, curling to shingles, See Pictures. Shingles are showing their age as some granular loss is visible but are in serviceable condition. Recommend budgeting for new roof as needed. Regular inspections and maintenance recommended to ensure roofing material will remain in serviceable condition.

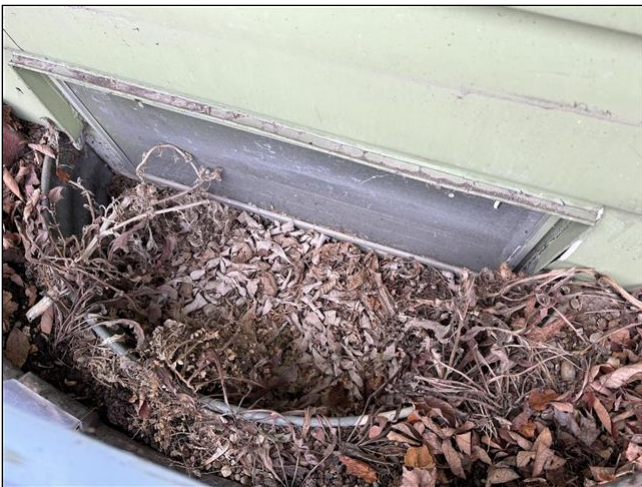
**2.2** Recommend cleaning out window wells, this will help with drainage of water and reduce chance of seepage into home. Some water stains found in basement during inspection, recommend asking seller about prior leaks

and time frames to determine frequency of water entering into the basement. Cleaning out window wells of debris is considered regular maintenance.

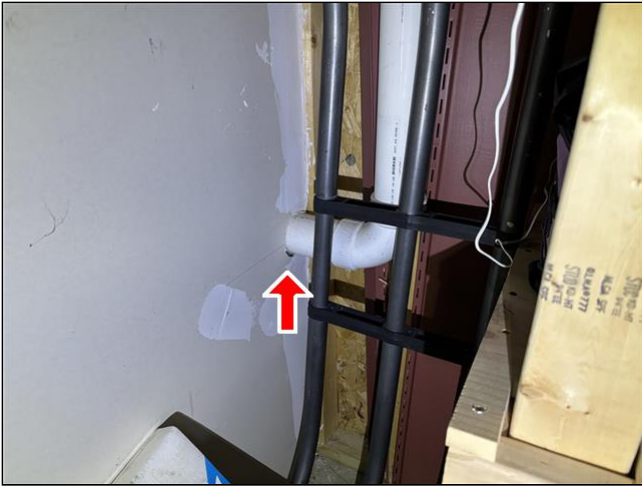
**3.1** When the radon mitigation system was installed in the home, an exhaust pipe was routed from basement up in to garage area and then up through the garage ceiling as seen in the pictures. It is recommended to install fire rated collars around the pipes along the wall where the pipe enters the garage and along the ceiling where the exhaust pipe exits up into the attic space. The fire collars are installed to ensure the fire barrier is maintained between the garage and living spaces of the home as the collars will expand and seal off the openings in the wall and ceiling if a fire does occur in the garage. Recommend a qualified person or contractor install the missing fire barrier collars in garage.

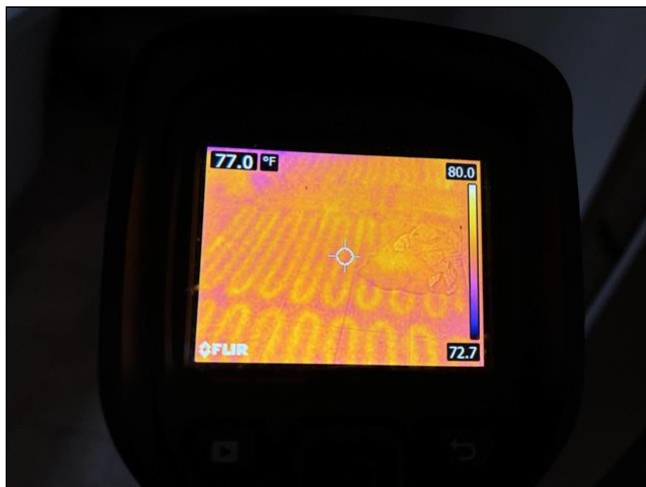
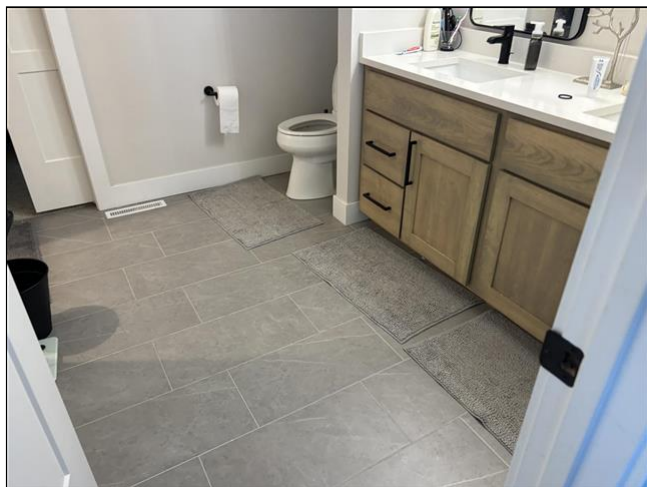
**4.2** Heated bathroom floors on main floor are working at time of the inspection. This is for your information.

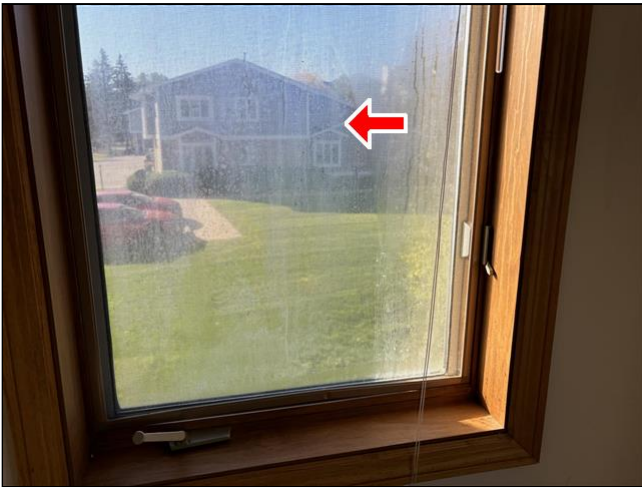
**4.6** The upper bedroom window facing rear of the home has a bad seal allowing moisture to enter between the window panes. This will cause the panes to look hazy and reduce homes energy efficiency. Recommend a qualified window technician provide pricing on replacement of bedroom window.

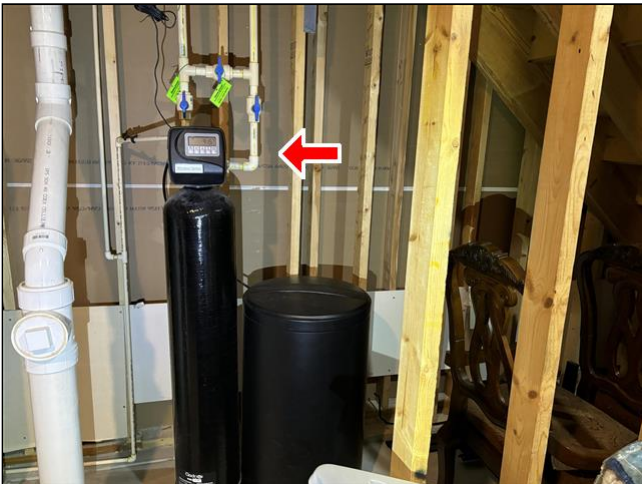
**6.1** Testing the effectiveness of the water softener system and water quality is beyond the scope of a standard home inspection. While most softener systems require little more attention than routinely adding salt to the reservoir, consider having it professionally inspected and tuned by your local dealer for proper operation and peak efficiency.

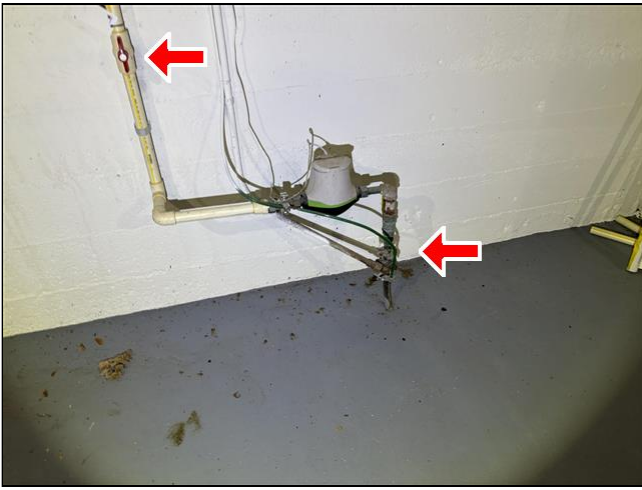
**6.3** Main water shut off for home is located in basement left of the water softener.

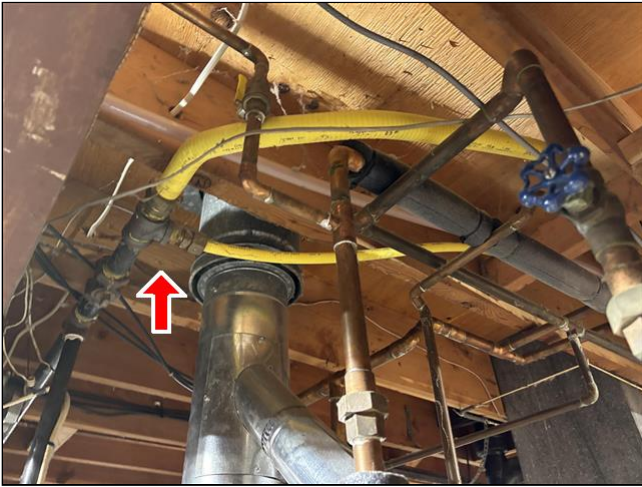
**6.4** Ungrounded CSST gas line observed in home. The manufacturer of this product has updated the installation instructions to include/require grounding to the homes electrical system. When originally installed there was no requirements for bonding CSST gas lines. I attached the updated bulletin with the inspection report. Recommend a licensed electrician perform work. It should be noted that this fix is for lightening protection of gas lines. In most cases the update can be completed quickly.

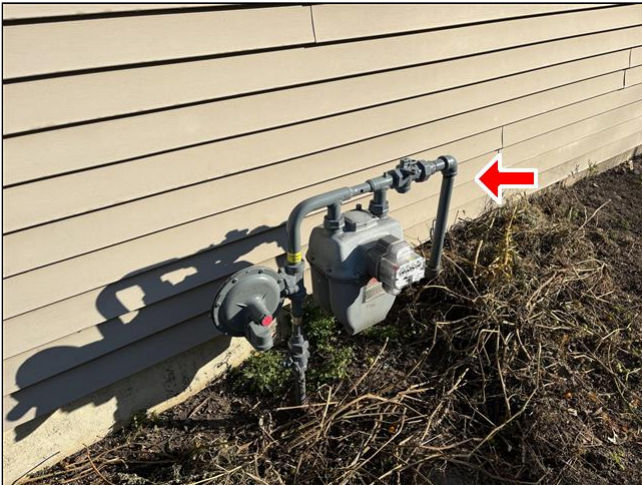
**6.5** Main gas meter and shut off to home is located along right side of the home along the exterior.

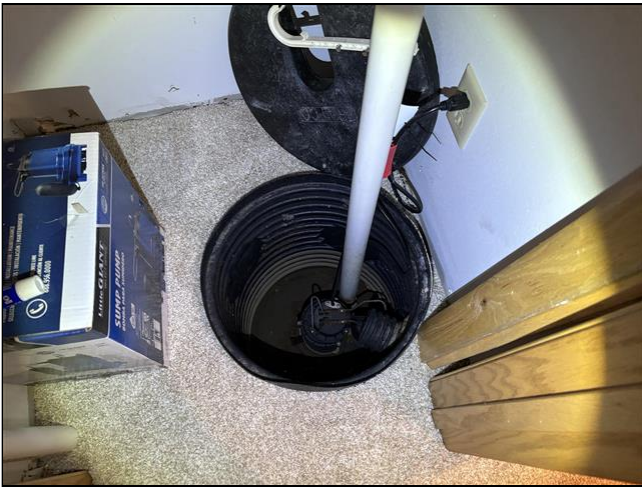
**6.6** Sump pump working at time of inspection. Recommend testing annually to ensure proper operation on sump pump unit. Drain tile system around the home was not inspected or tested.

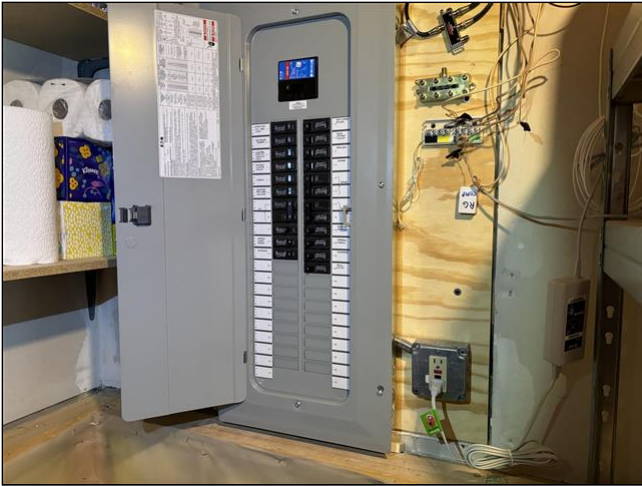
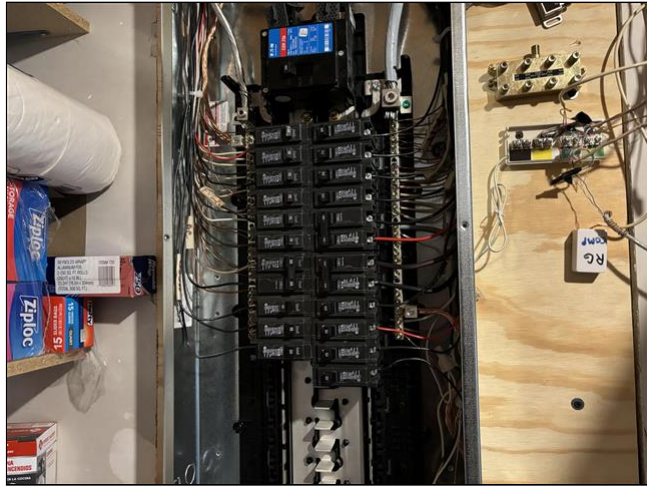
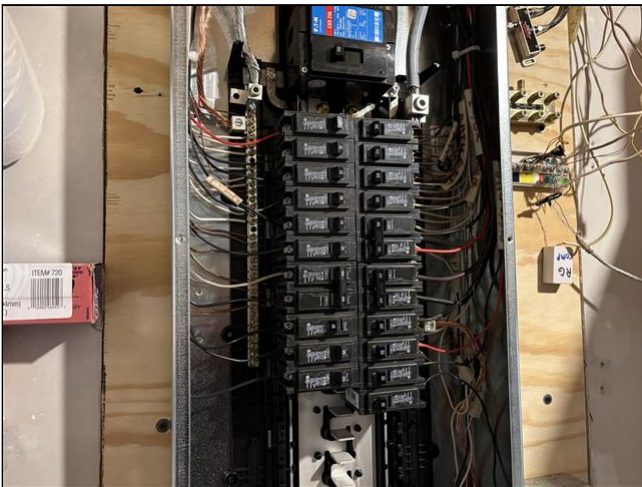
**7.6** Main 200 amp Eaton electrical panel is located in basement storage room. No issues found at time of the inspection.

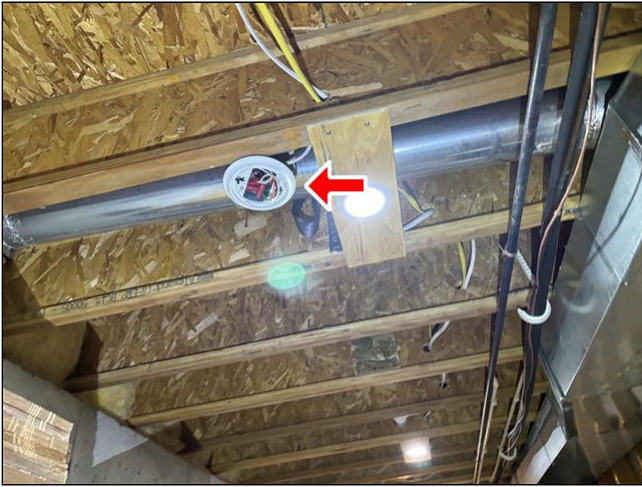
**7.7** Several of the smoke detectors on 2nd floor and on main floor are well beyond the manufacturers recommended 10 year replacement date. Recommend replacing smoke detectors and installing per manufacturers instructions. All smoke detectors should be tested upon move in and placed on a monthly testing program to ensure they are working properly. State of Wisconsin requires a minimum of one smoke detector per floor of home, but recommend referencing you to your particular local code. Some municipalities want smoke detectors installed in the following areas: In each bedroom, within 6 feet of each door leading to a bedroom or sleeping area and at least one smoke detector on each floor of a building. Also the smoke detector in the basement is missing and new detector should be installed.

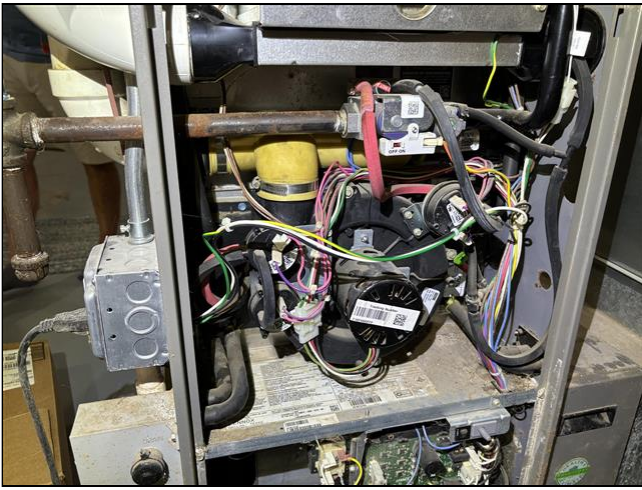
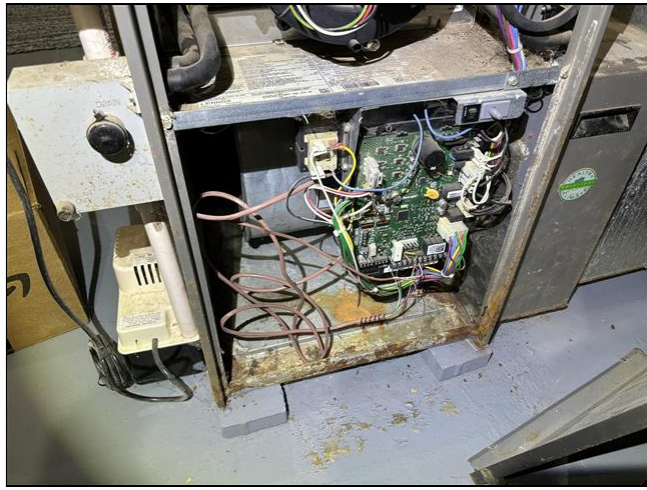
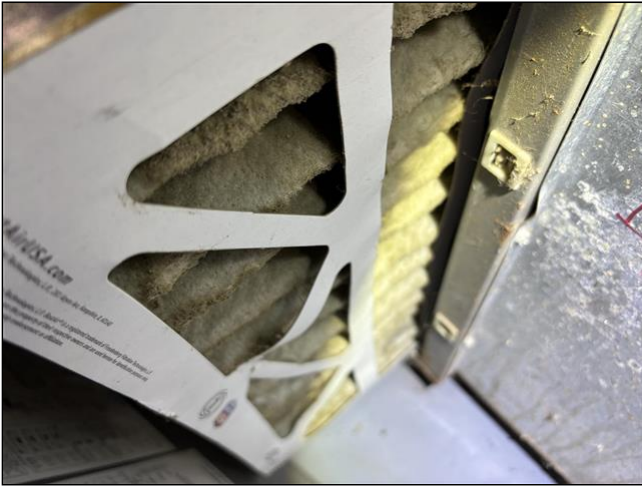
**8.0** Furnace in basement for heating home tested ok at time of inspection. Unknown when last serviced as no service record found, recommend asking seller. Furnace is 20 years old and the average life expectancy is 25 years for a furnace of this type. Given age of the furnace and condition of the furnace, it is recommended that you have regular service check up performed on the unit to ensure it remains in working order. Furnace was very dirty and filter was in need of replacing, this is considered regular maintenance.

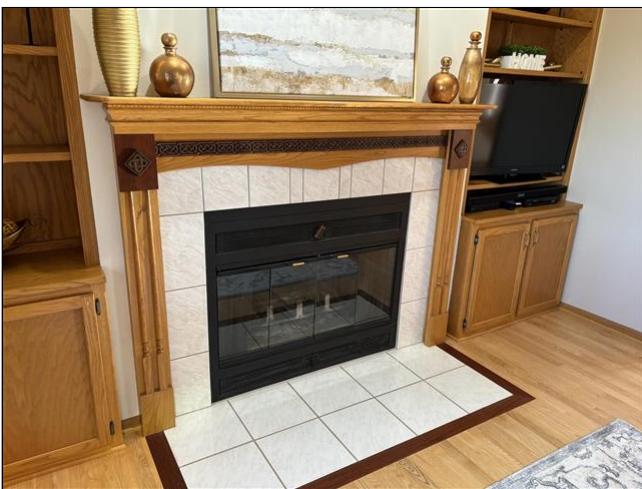
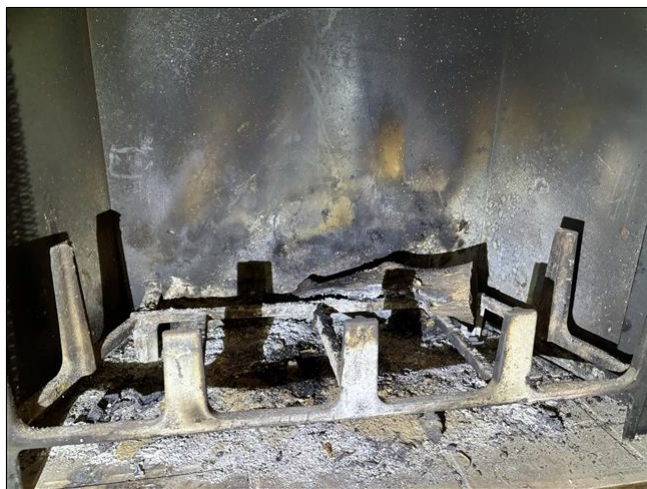
**8.6** The home inspection is a component inspection and not a functionality inspection. I do not inspect the shape of fireplace or the design to determine if your fireplace has a proper air draw(drafting). Recommend a certified chimney inspector inspect the chimney flue prior to use as they can determine the condition of the flue and whether safe to use. It is never recommended to leave the fireplace un-attended when in use. Also should be noted that the chimney liner was not visible due to dampener and chimney rain cap, recommend a licensed chimney company clean and inspection flue as creosote dust may conceal a hairline crack until properly cleaned and inspected. I recommend a qualified chimney sweep inspect for safety prior to first use as unknown when fireplace was last used or inspected.

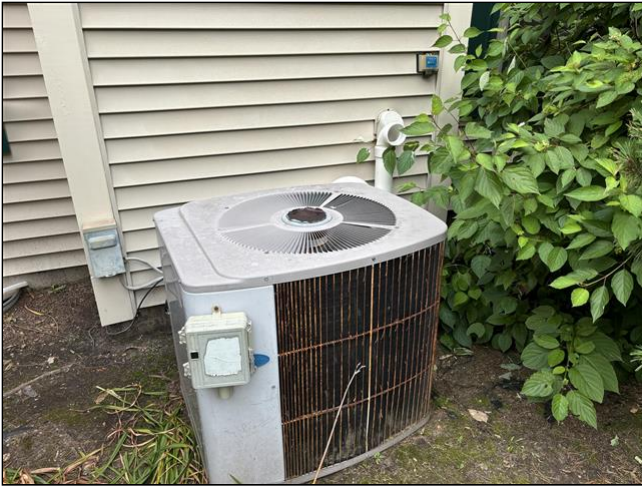
**8.8** The condenser outside (AC unit) is beyond its 25 year life expectancy as it is 34 years old but could last several more years. I have seen a/c units fail after a home inspection as the seasonal hot weather returns. I cannot determine how long your AC will last and recommend budgeting for replacement or as necessary. The temperature Differential of the a/c unit when tested was 14 degrees meaning its on the low side of producing cool air for home but passing. Usually anywhere between 14 up to 22 degrees is good. This is for your information.

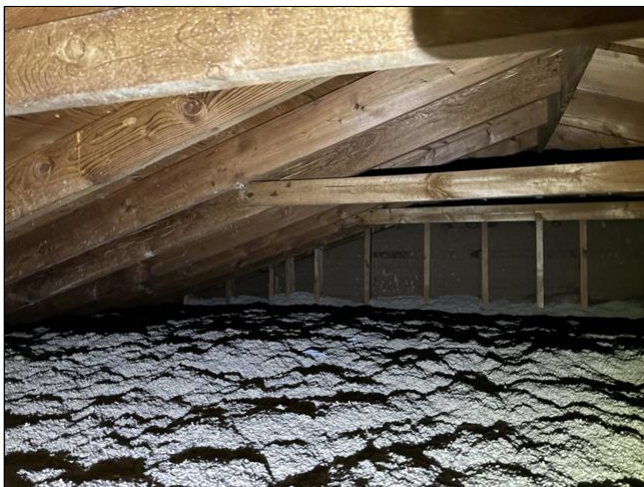
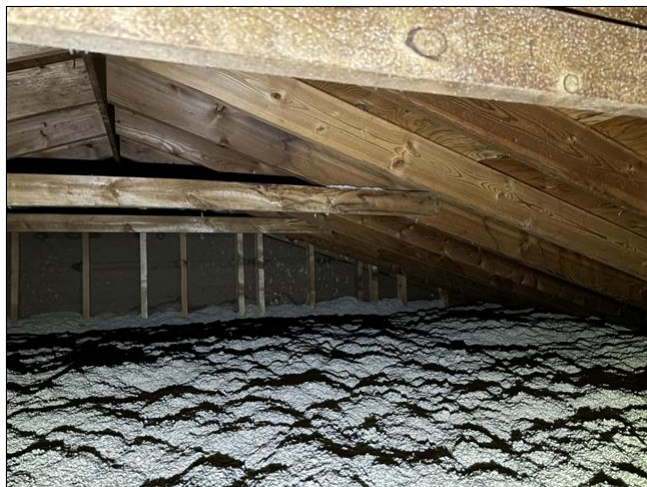
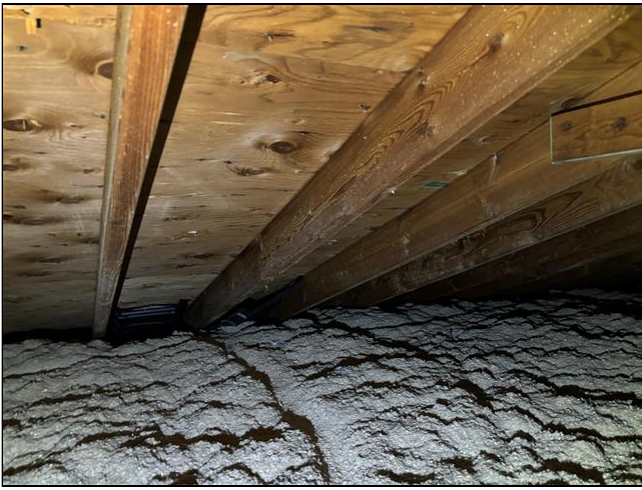
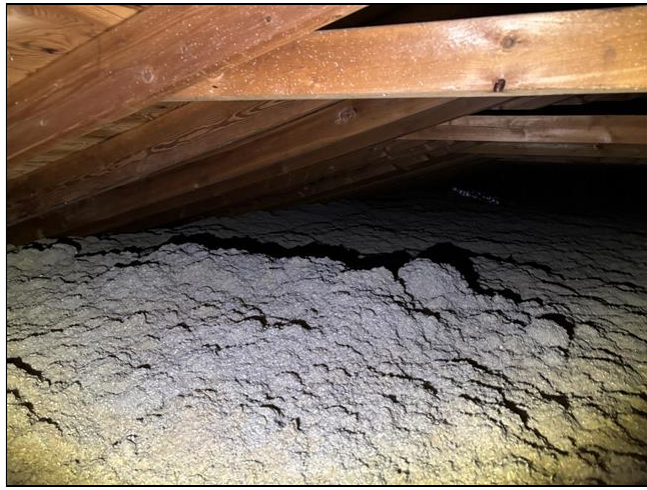
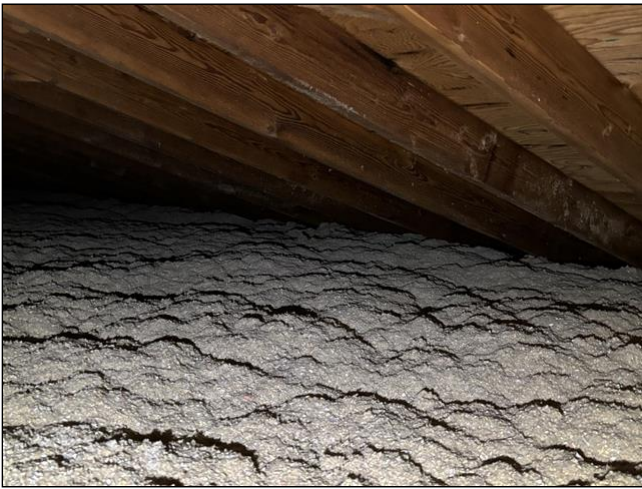
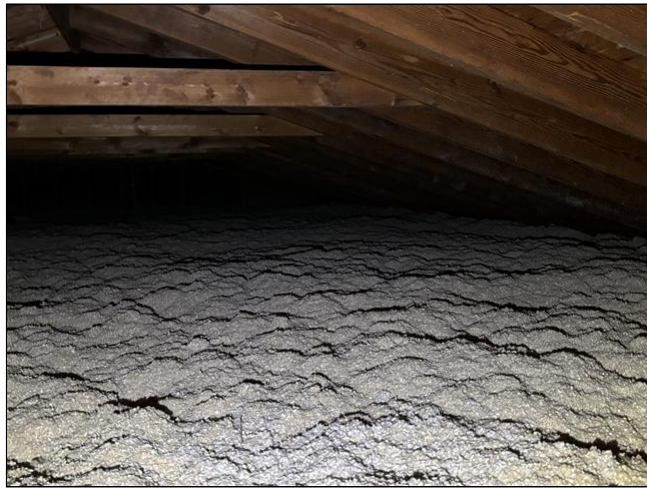
**9.0** Home is well insulated with a blown in cellulose with an estimated insulation value of R38 or better, no visible issue found at time of inspection.

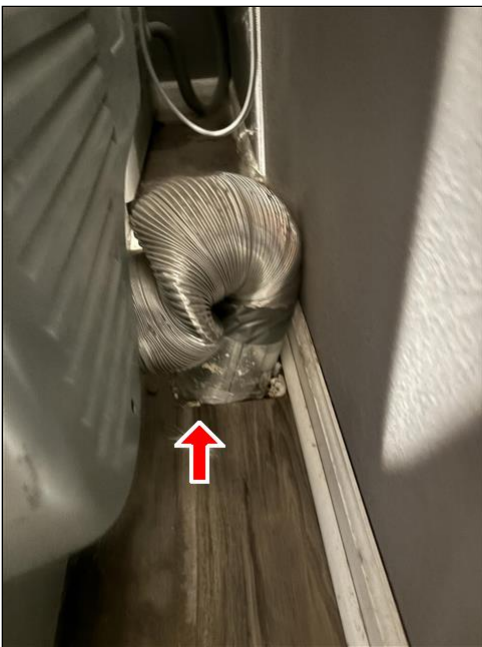
**9.8** Dryer exhaust piping behind dryer on main floor is damaged and will restrict air flow causing increased drying times and possible dryer air flow blockage.

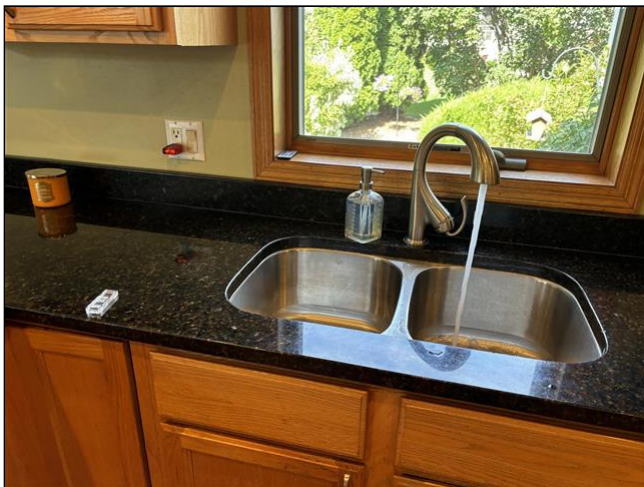
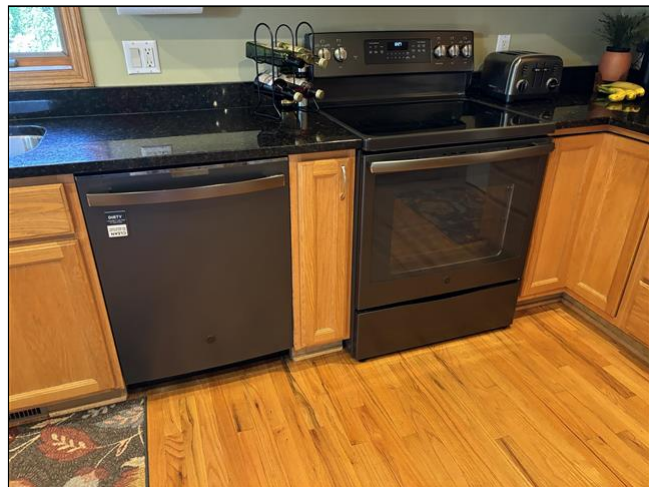
**10.0** No above counter top air gap or a high loop below in vanity for dishwasher discharge was found. It is recommend to have an air gap device which can prevent contaminated water from draining back into the dishwasher. Recommend a qualified plumber install proper air gap device.

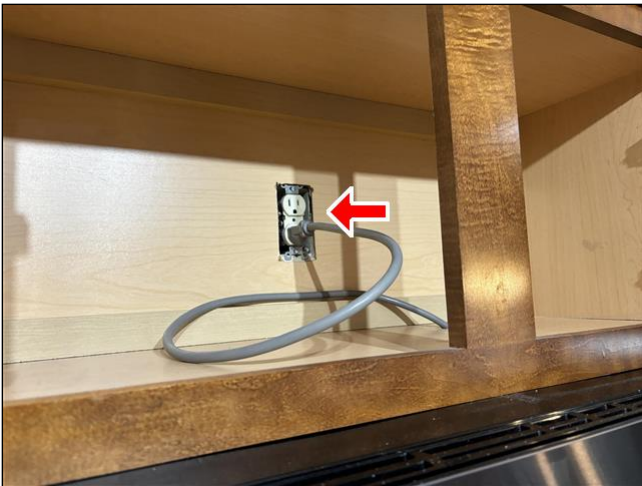
**10.5** Outlet above microwave in kitchen cabinet is missing the electrical cover. An electrical cover should be installed as exposed electrical connections are considered an electrical safety hazard until corrected.

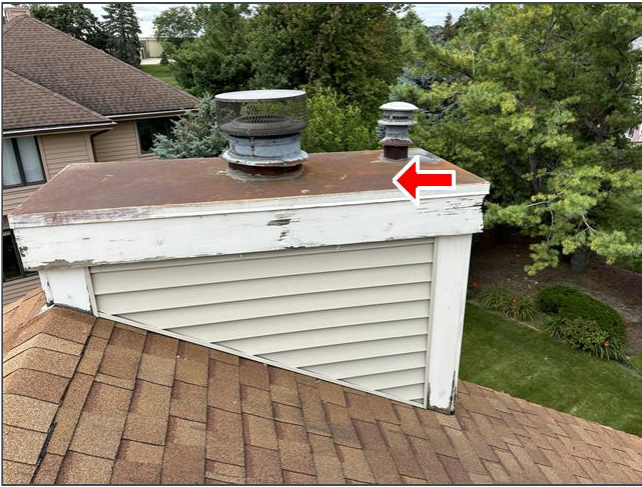
#### 1.2 Skylights, Chimneys and Roof Penetrations

**1.2** Metal chimney cap is rusting and in need of replacement or possibly sanding and applying a protective coating to reduce further rusting of metal chimney cap. Further rusting can cause leaking into chimney chase. Qualified chimney technician to evaluate and provide options to correct rusting issue of the chimney cap.

Metal chimney cap is rusting and in need of replacement or possibly sanding and applying a protective coating to reduce further rusting of metal chimney cap. Further rusting can cause leaking into chimney chase. Qualified chimney technician to evaluate and provide options to correct rusting issue of the chimney cap.

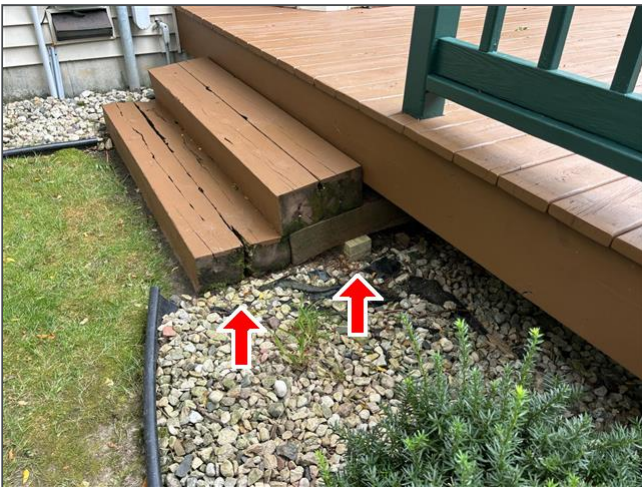
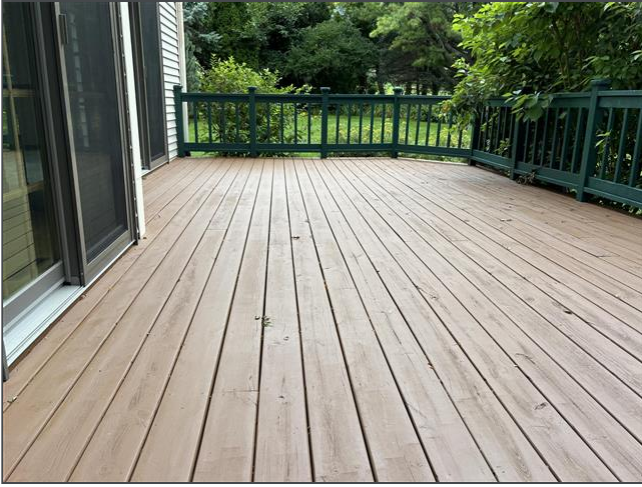
#### 2.3 Decks, Balconies, Stoops, Steps, Areaways, Porches, Patio/Cover and Applicable Railings

**2.3** The Wood deck posts supporting the main deck are older and several posts are failing. The wood posts are rotted and/or split and could cause the deck to collapse at some point. Recommend a qualified contractor evaluate and determine repairs needed to ensure the deck is safe for use. Also the deck steps have moved due to visible moisture damage and wood rot found. Temporary repairs made to the deck steps were visible. Deck stairs will need repairs and/or possible full replacement.

The Wood deck posts supporting the main deck are older and several posts are failing. The wood posts are rotted and/or split and could cause the deck to collapse at some point. Recommend a qualified contractor evaluate and determine repairs needed to ensure the deck is safe for use. Also the deck steps have moved due to visible moisture damage and wood rot found. Temporary repairs made to the deck steps were visible. Deck stairs will need repairs and/or possible full replacement.

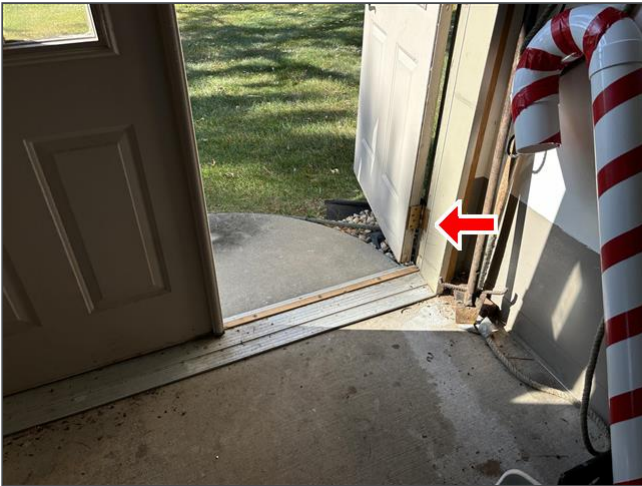
**2.1 Doors (Exterior)**

**2.1** Lower door hinge to side entrance of storage room is coming loose as visible moisture damage to door frame found, this is causing door to bind against frame when trying to open/close. Recommend qualified person or contractor ensure door hinge can be properly tightened so hinge is secure and not loose, the door will need to be properly supported by hinges to open/close properly.

Lower door hinge to side entrance of storage room is coming loose as visible moisture damage to door frame found, this is causing door to bind against frame when trying to open/close. Recommend qualified person or contractor ensure door hinge can be properly tightened so hinge is secure and not loose, the door will need to be properly supported by hinges to open/close properly.

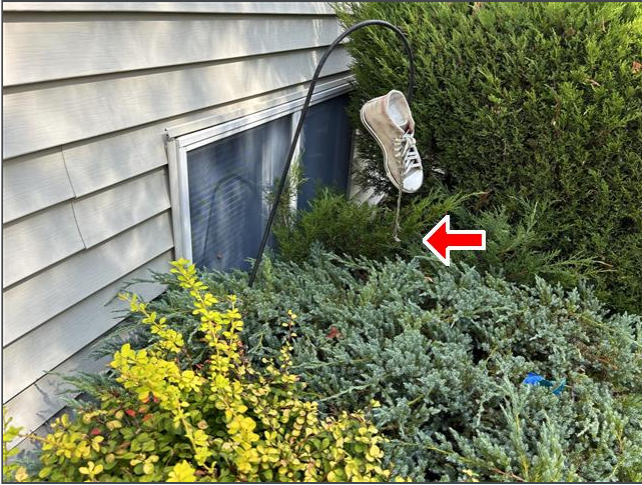
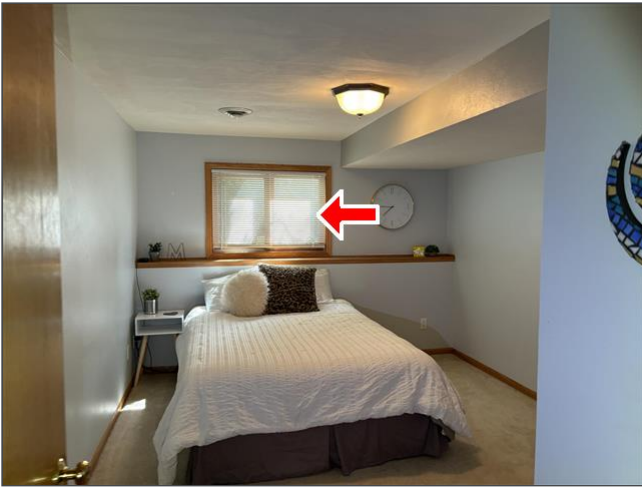
**2.2 Windows**

**2.2** Lower bedroom egress window blocked by over growth of bushes(see pictures), this is a safety issue and should be corrected by removing exterior bushes in front of the window in case there ever is a cause to escape the room including due to a fire, the escape route should never be blocked.

Lower bedroom egress window blocked by over growth of bushes(see pictures), this is a safety issue and should be corrected by removing exterior bushes in front of the window in case there ever is a cause to escape the room including due to a fire, the escape route should never be blocked.

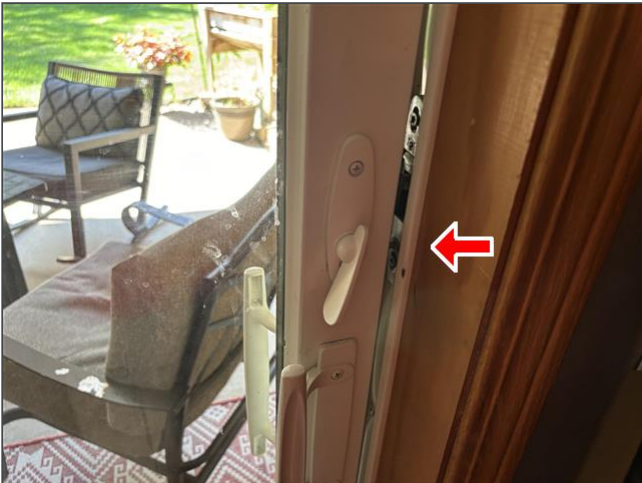
### **2.1 Doors (Exterior)**

Master bedroom sliding glass door to rear deck did not lock properly as latch is mis-adjusted, Recommend a qualified person or technician properly adjust door latch to ensure door can be locked properly for safety of occupants in the home.

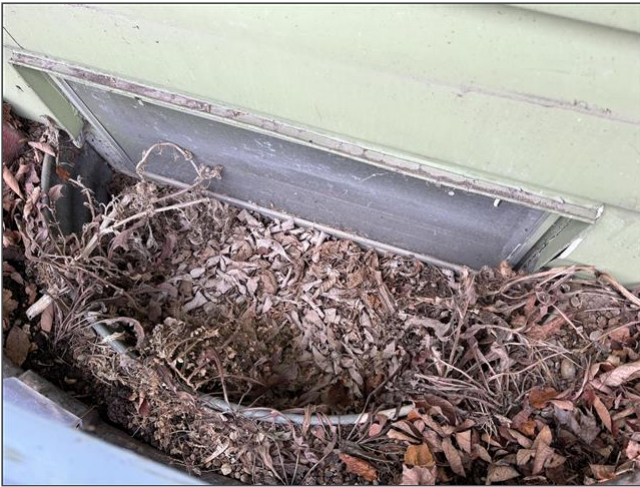
Recommend cleaning out window wells, this will help with drainage of water and reduce chance of seepage into home. Some water stains found in basement during inspection, recommend asking seller about prior leaks and time frames to determine frequency of water entering into the basement. Cleaning out window wells of debris is considered regular maintenance.

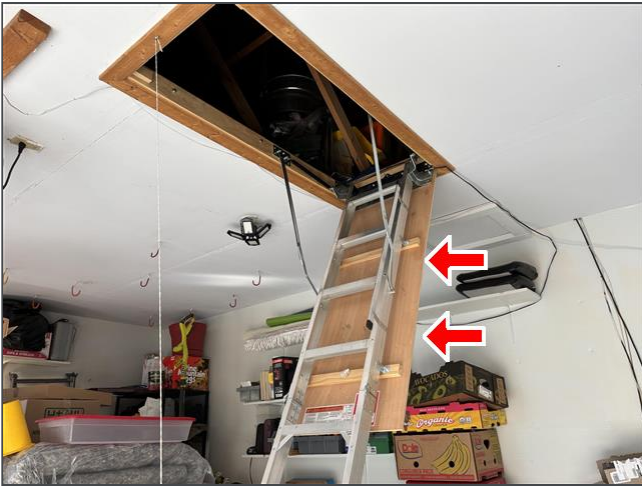
##### 3.0 Garage Ceilings

Fire barrier between garage and attic space was broken due to attic ladder being installed and not being a fire rated ladder. The ladder assembly panel is only a 1/4 inch piece of wood or less in thickness so if fire was to occur in garage it would be able to enter into the attic area rather quickly. Recommend installing protective fire barrier material over the ladder panel so the fire barrier will be maintained or consider upgrading to a fire rated ladder assembly.

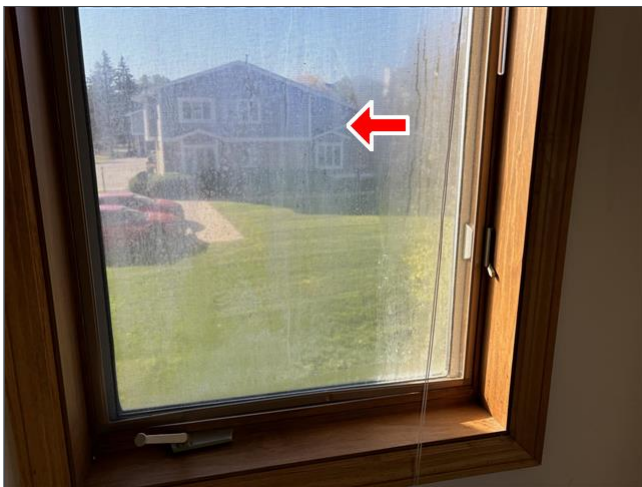
#### 4.6 Windows (representative number)

The upper bedroom window facing rear of the home has a bad seal allowing moisture to enter between the window panes. This will cause the panes to look hazy and reduce homes energy efficiency. Recommend a qualified window technician provide pricing on replacement of bedroom window.

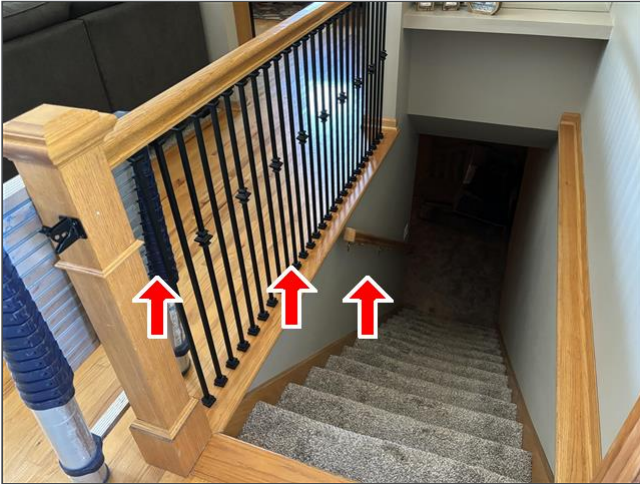
**Repair****4.3 Steps, Stairways, Balconies and Railings**

No graspable hand rail along the entire length of the stairs was found leading to the basement area of the home. Recommend installing a hand rail along entire length of the steps to meet today's safety standards. A fall or injury could occur if not corrected. A qualified contractor or person is recommended to perform the work.

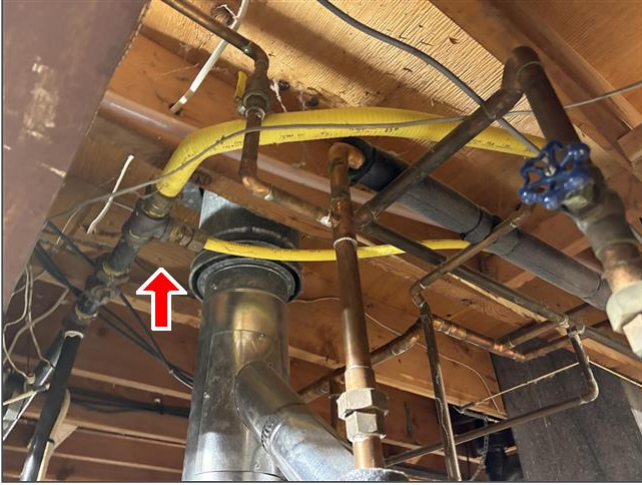
#### 6.4 Fuel Storage and Distribution Systems (Interior fuel storage, piping, venting, supports, leaks)

Ungrounded CSST gas line observed in home. The manufacturer of this product has updated the installation instructions to include/require grounding to the homes electrical system. When originally installed there was no requirements for bonding CSST gas lines. I attached the updated bulletin with the inspection report. Recommend a licensed electrician perform work. It should be noted that this fix is for lightening protection of gas lines. In most cases the update can be completed quickly.

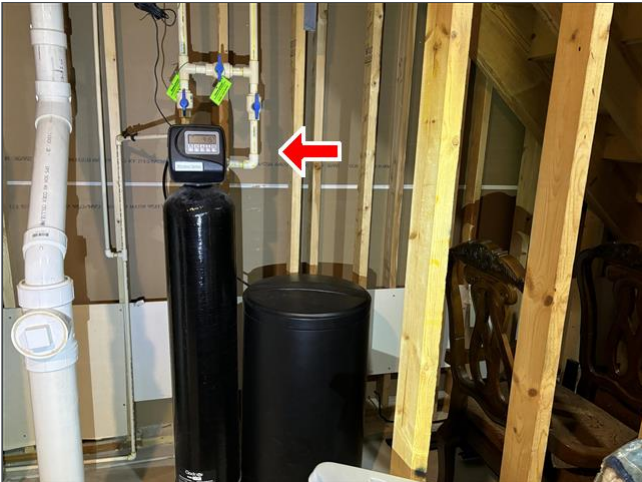
#### 6.1 Plumbing Water Supply, Distribution System and Fixtures

Testing the effectiveness of the water softener system and water quality is beyond the scope of a standard home inspection. While most softener systems require little more attention than routinely adding salt to the reservoir, consider having it professionally inspected and tuned by your local dealer for proper operation and peak efficiency.

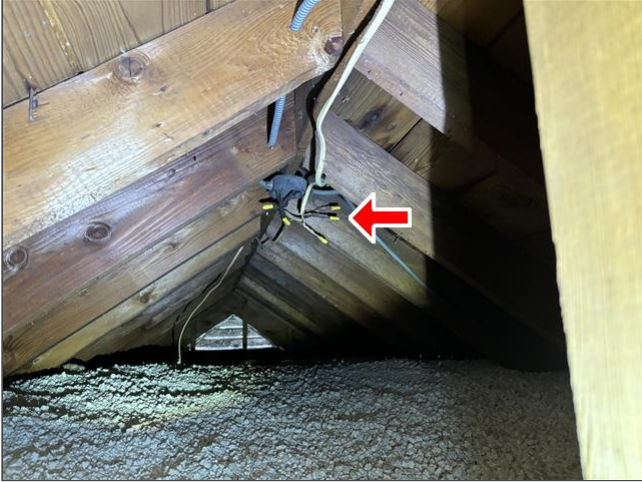
7.3 Connected Devices and Fixtures (Observed from a representative number operation of ceiling fans, lighting fixtures, switches and receptacles located inside the house, garage, and on the dwelling's exterior walls)

Open wiring connections (splices) found in attic space above the garage which should be placed in an enclosed electrical junction box, Recommend a qualified electrician repair wiring issues in attic space above garage. This is considered an electrical safety issue until corrected.

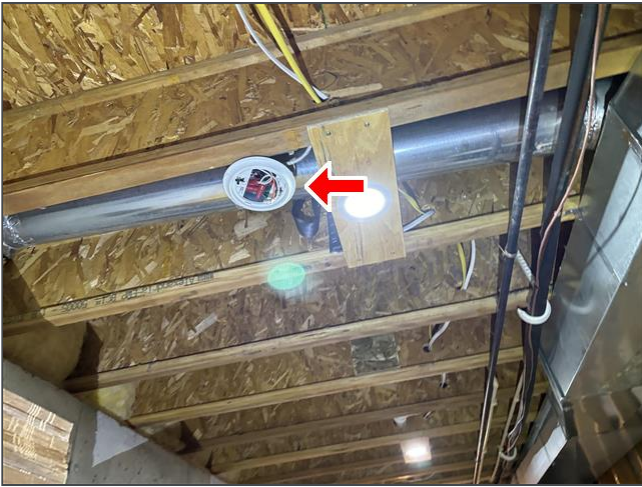
### 7.7 Smoke Detectors

Several of the smoke detectors on 2nd floor and on main floor are well beyond the manufacturers recommended 10 year replacement date. Recommend replacing smoke detectors and installing per manufacturers instructions. All smoke detectors should be tested upon move in and placed on a monthly testing program to ensure they are working properly. State of Wisconsin requires a minimum of one smoke detector per floor of home, but recommend referencing you to your particular local code. Some municipalities want smoke detectors installed in the following areas: In each bedroom, within 6 feet of each door leading to a bedroom or sleeping area and at least one smoke detector on each floor of a building. Also the smoke detector in the basement is missing and new detector should be installed.

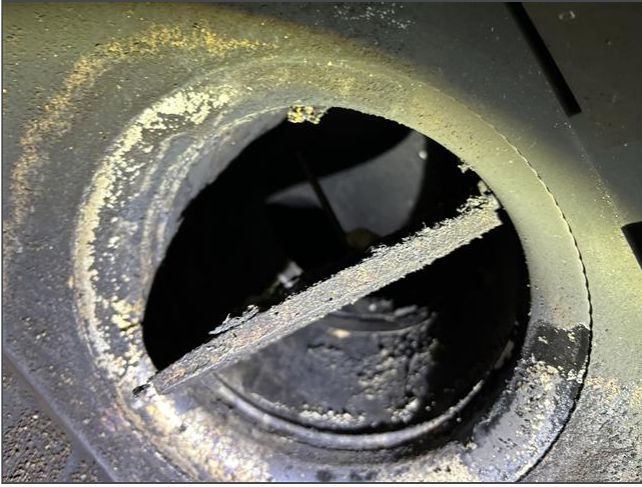
**8.6 Solid Fuel Heating Devices (Fireplaces, Woodstove)**

The home inspection is a component inspection and not a functionality inspection. I do not inspect the shape of fireplace or the design to determine if your fireplace has a proper air draw(drafting). Recommend a certified chimney inspector inspect the chimney flue prior to use as they can determine the condition of the flue and whether safe to use. It is never recommended to leave the fireplace un-attended when in use. Also should be noted that the chimney liner was not visible due to dampener and chimney rain cap, recommend a licensed chimney company clean and inspection flue as creosote dust may conceal a hairline crack until properly cleaned and inspected. I recommend a qualified chimney sweep inspect for safety prior to first use as unknown when fireplace was last used or inspected.

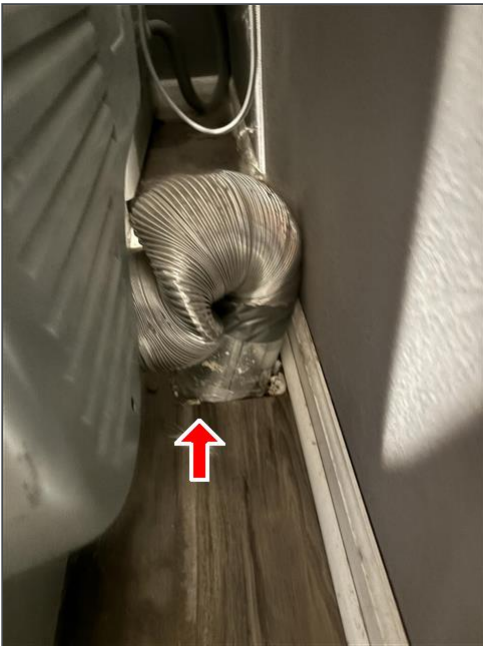
#### 9.8 Dryer Exhaust

Dryer exhaust piping behind dryer on main floor is damaged and will restrict air flow causing increased drying times and possible dryer air flow blockage.

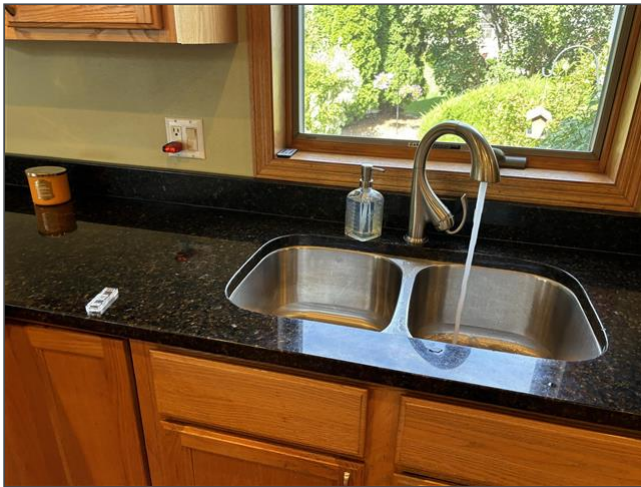
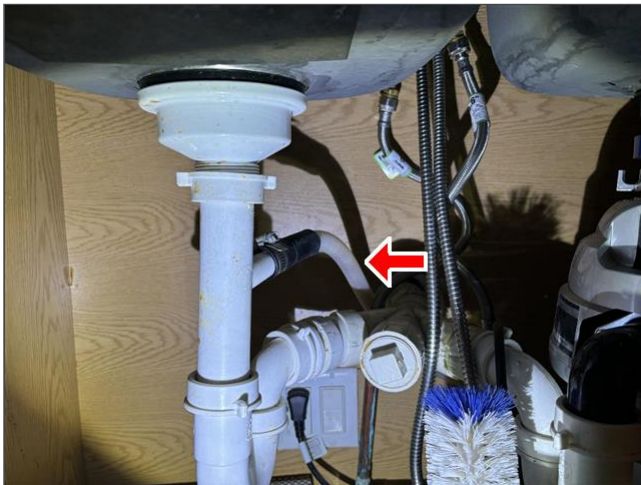
#### 10.0 Dishwasher

No above counter top air gap or a high loop below in vanity for dishwasher discharge was found. It is recommend to have an air gap device which can prevent contaminated water from draining back into the dishwasher. Recommend a qualified plumber install proper air gap device.

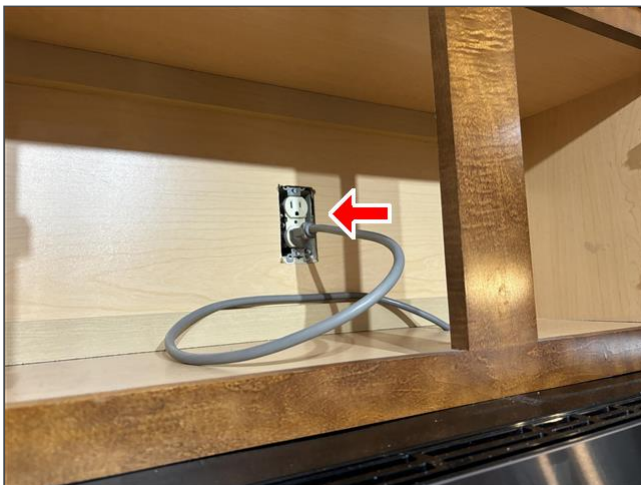
#### 10.5 Microwave Cooking Equipment

Outlet above microwave in kitchen cabinet is missing the electrical cover. An electrical cover should be installed as exposed electrical connections are considered an electrical safety hazard until corrected.
